VINGT-TROISIÈME CONGRÈS
DES GRANDS BARRAGES
Brasilia, Mai 2009

REHABILITATION OF THE PIAN TELESSIO DAM (IT) AFFECTED BY AAR-REACTION¹

Lombardi Engineering Ltd.
SWITZERLAND

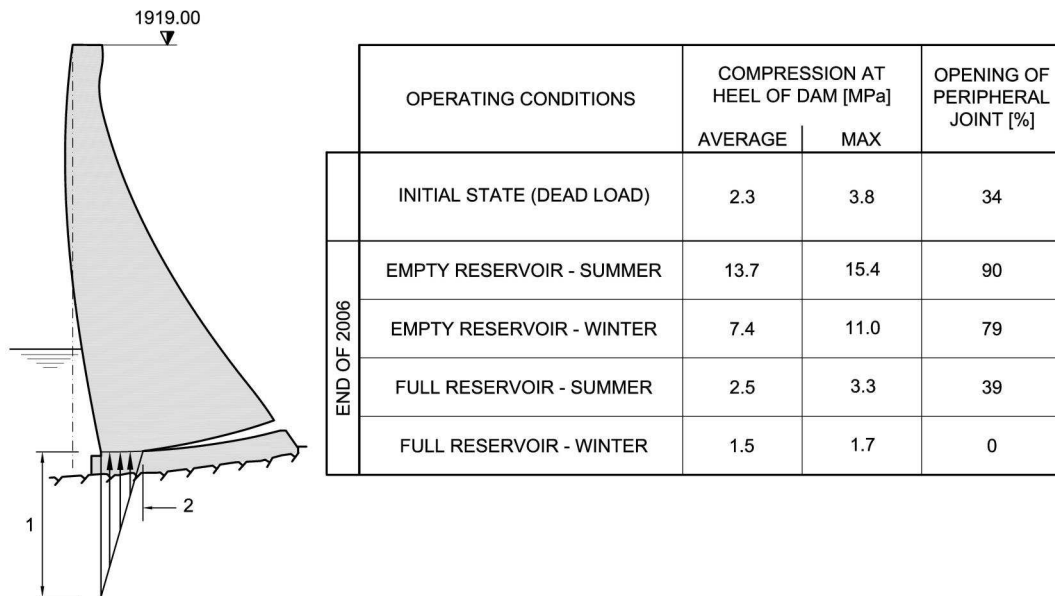
Fig. 2

stress distribution is the increase of the arch compressive stresses as well as the increase of the compressive stresses at the upstream toe of the perimetral joint. Figure 2 shows the cinematic behaviour of the dam with the schematic increase of the compressive stresses along the perimetral joint.

Compressive stresses at the upstream toe of the dam.

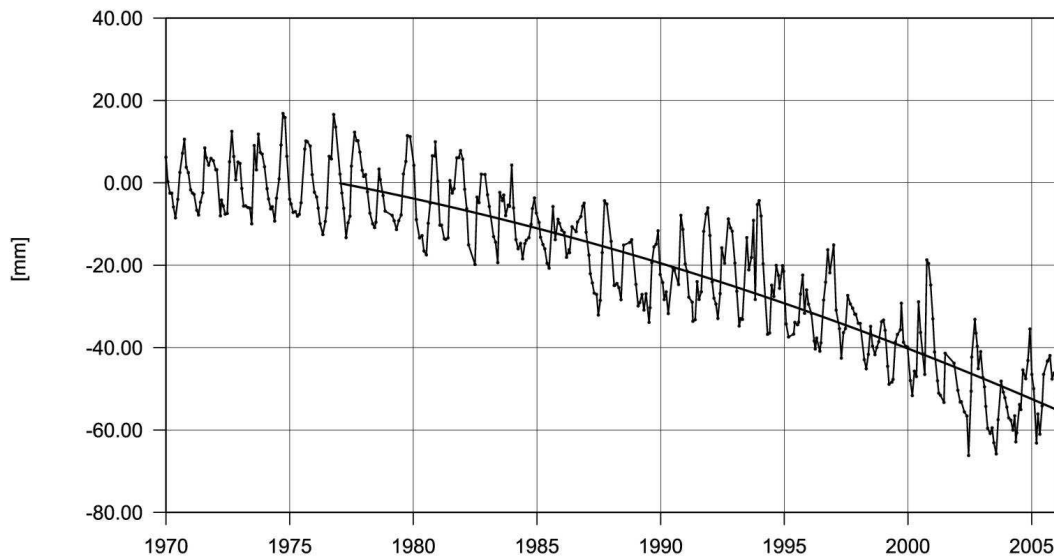
After the dam was put into operation in 1955, the behaviour observed during the first 20 years was in agreement with the expected one. As shown in Figure 3, since almost 1980 a permanent deformation in the upstream direction in particular at the centre of the dam crest was recorded. Approximately 15 years later the permanent deformation was no longer questionable and investigations were started to identify their causes.

Fig. 3
Radial crest displacements since 1970 (+ downstream, - upstream)
Déplacements radiaux en crête depuis 1970 (+ amont, - aval)

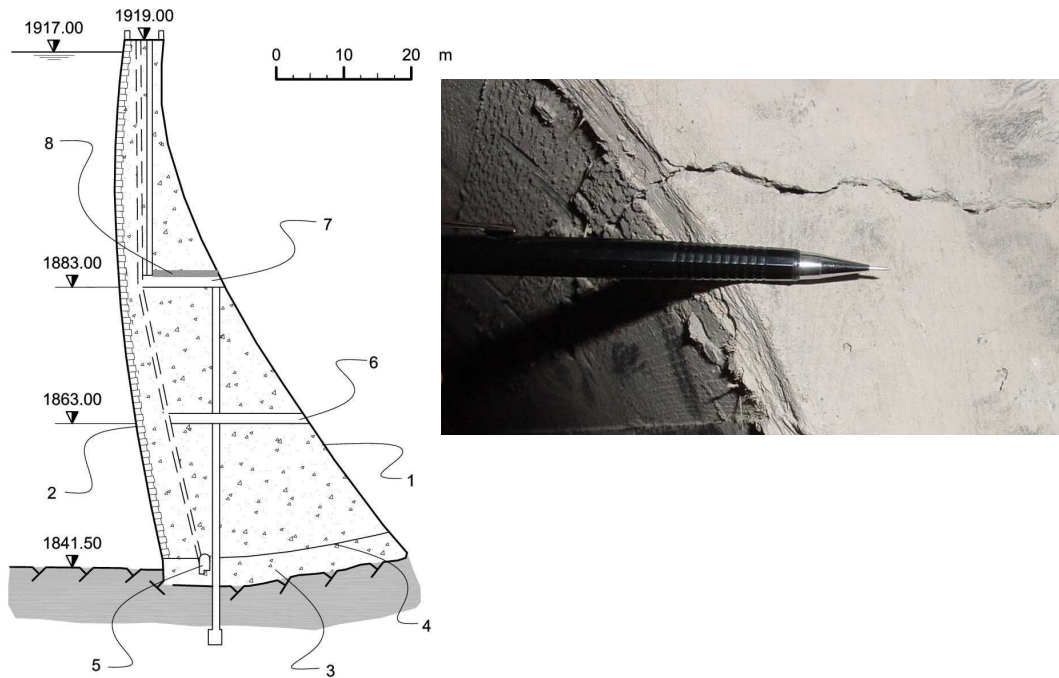
Fig. 4

In addition to the permanent deformations some horizontal cracks appeared in the upper inspection gallery developing progressively into one single continuous crack (Fig. 4).

Crack in the upper gallery.
Fissure dans la galerie supérieure.

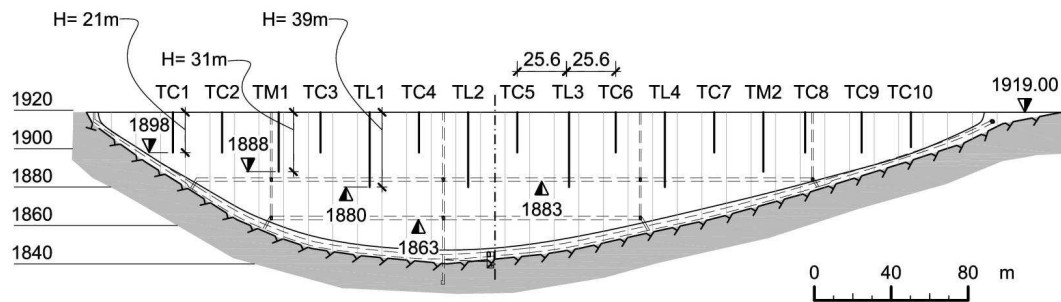
Fig. 5
Position of slot cuttings.
Position des sciages.

The project proposes the execution of 16 vertical slots with variable height of 21, 31 and 39 m (Fig. 5). The distance between adjacent slots is around 26 m and the total cutting surface arises up to 3500 m². Table 1 resumes the main characteristics of the cuts.
