REPAIR WORKS AT FLUMENDOSA ARCH DAM (*)**R. SILVANO***Project Management**Ente Autonomo del Flumendosa***F. FRONGIA***Project Management**Ente Autonomo del Flumendosa***A. MONDADA***Head of structural analyses department**Lombardi Engineering Ltd.***A. PIAZZA***Design Engineer**Lombardi Engineering Ltd.***ITALY****1. INTRODUCTION**

The 115 m high double curvature arch dam of Nuraghe Arrubiu on the Flumendosa river, owned by the "Ente Autonomo del Flumendosa" of Cagliari in Sardinia, was completed in 1957 after a 5 years construction period. The dam is part of an extensive drinking water and irrigation system of the the city of Cagliari and shows an active storage capacity of nearly $300 \cdot 10^6 \text{ m}^3$. Already at final construction stage and immediately after its completion, a great number of cracks appeared on the upper part of the upstream face. As consequence, for nearly 40 years the reservoir was impounded only partially with a maximum water level 31 m below the design level and a $\frac{2}{3}$ loss of its storage capacity.

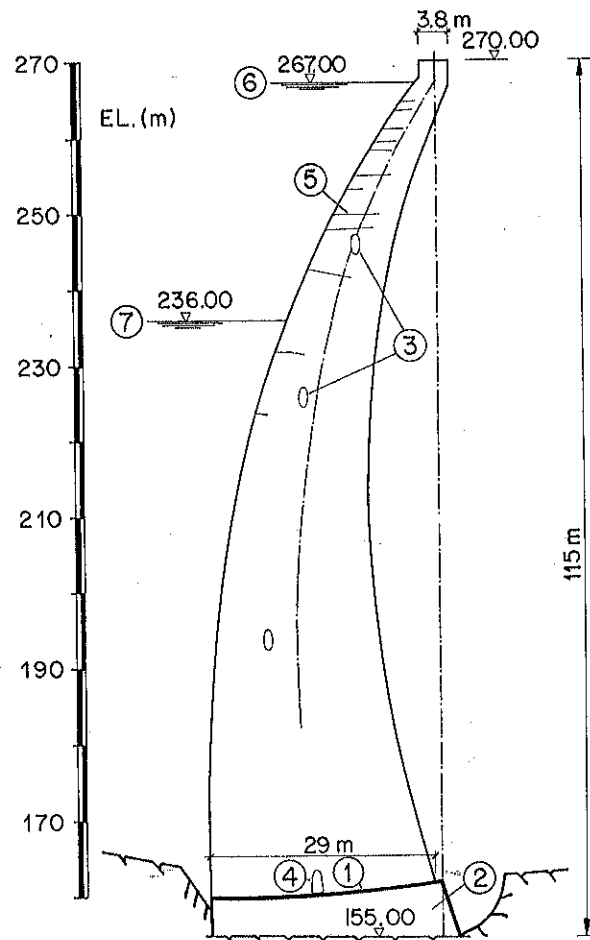
Fig. 2: Cross section at the crown.
Section en clef de voûte.

Despite of the relatively low stresses resulting from the analysis, numerous cracks were recorded mainly in the lift joints of the upper zone of the upstream face as schematically shown in Fig. 2. During the first years of operation, the cracking further extended with a propagation of the existing and the developing of new cracks. The phenomenon slowed down progressively and since 1971 no new cracks were detected.

Core drillings indicate that the cracks depth is relatively limited near the dam crest as well as below 220 m a.s.l., whereas it may attain 60% of the dam thickness in between.

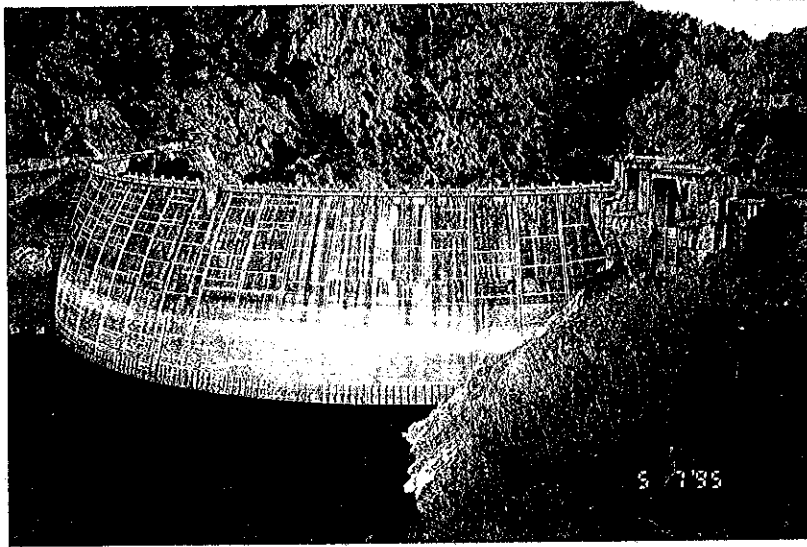
The general aspect of the upstream dam face, as shown in **Figure 3**, attests the extensive opening of the lift joints. A total of nearly 176 one-block-long cracks were detected.

Fig. 3: View of the upstream face attesting the extend of open lift joints.
Vue du parement amont mettant en évidence l'étendue des joints de reprise ouverts.

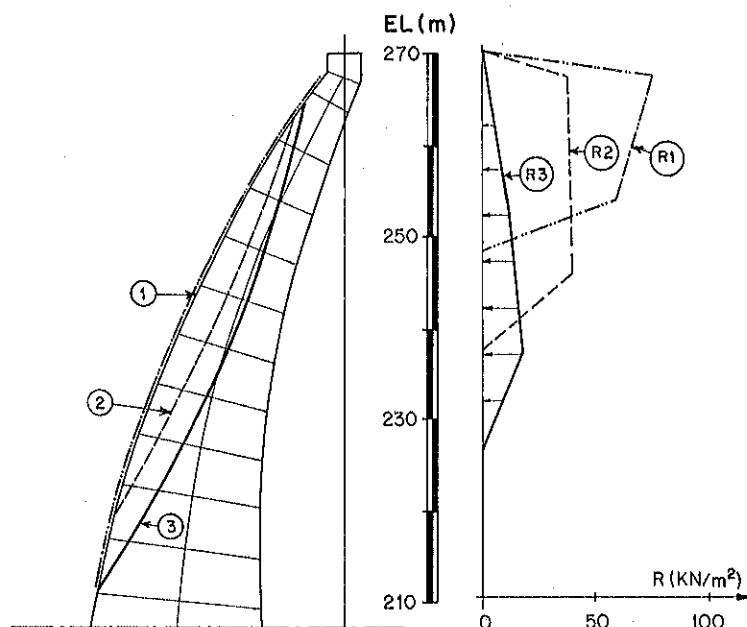
Due to the very important downstream overhang, the upper zone of an independent cantilever (before grouting the contraction joints) is not stable under its own weight. Stability could therefore only be achieved by grouting the contraction joints in order to allow the arches to act as soon as possible. But, due to the fast progress of the concrete placing, the grouting had to take place before the hydration heat could dissipate completely. It has to be mentioned that no artificial cooling by embedded pipes was used, which resulted in a relatively slow cooling of the concrete. At the time the concrete pouring was completed, the temperature of the upper zone exceeded thus by far the yearly average temperature. Following, the cooling continued well after the construction was finished. Furthermore, the presence of a geological fault on one abutment delayed the concreting works of some lateral blocks. The effective concrete placement was thus significantly different from the planned schedule. Consequently, at the end of the construction, the temperature of the upper dam zone was generally higher at the abutments than at the crown.

Due to the reduced thickness of the crest, the cooling was there more rapid than at lower elevations where the dam is quite thicker. The decrease of the temperature resulted in a shortening of the arches causing a downstream deformation of the blocks. Consequently, the tensile stresses on the upstream face further increased leading to the described crack pattern.

Figure 4 shows the influence of the reaction forces between cantilevers and arches on the extend of the zone of vertical tensile stresses. The progressive reduction of the arch action due to the decrease of the concrete temperature is schematically shown by the forces "R1" to "R3".

Fig. 4: Influence of arch reaction forces on the extension of the zone of tensile stresses in the crown cantilever.

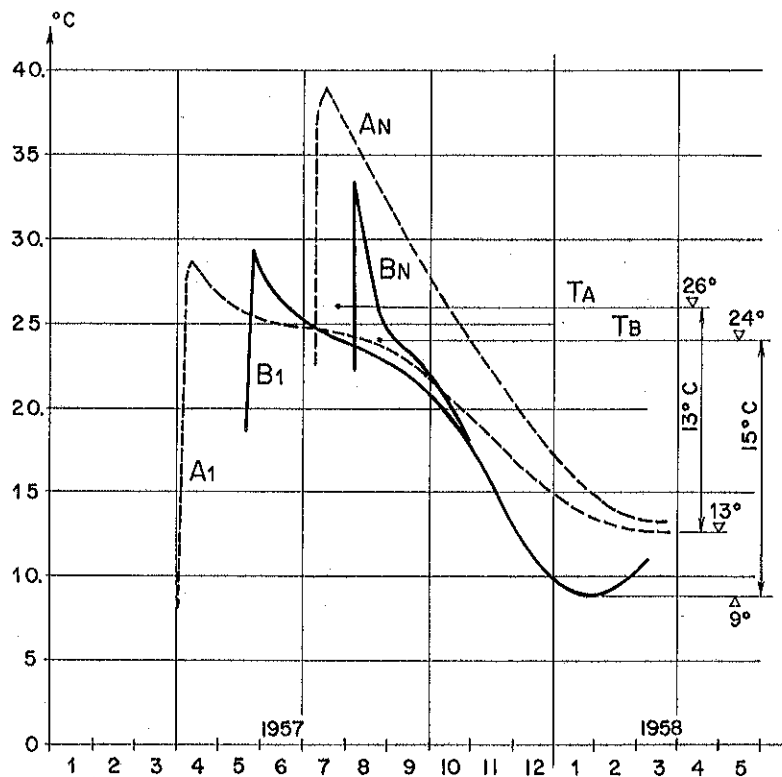
As shown in this figure at the end of July 1957, the joints at elevation 254 m a.s.l. were grouted while the average temperature was approximately 26°C.

Fig. 5: Results of the thermal analysis for the arches at el. 254 and 270 m a.s.l.
Résultats de l'analyse thermique pour les arcs aux niveaux 254 et 270 m s.m.

Similarly, the arch at 270 m a.s.l. was completed at mid August 1957 and its average temperature was then approximately 24°C. Approximately 6 months later, the average temperature had decreased significantly to a value of 13°C for the arch at 254 m a.s.l. and to 9°C at the dam crest. At lower elevations the temperature decreased in the same period by only 3-5°C.

The cooling that took place after the grouting of the joints resulted in a downstream deformation of the crest of 34 mm producing a bending of the cantilevers. This relevant deformation entirely explains the wide zone of tensile stresses in the dam body and the extensive cracking at the upstream face.

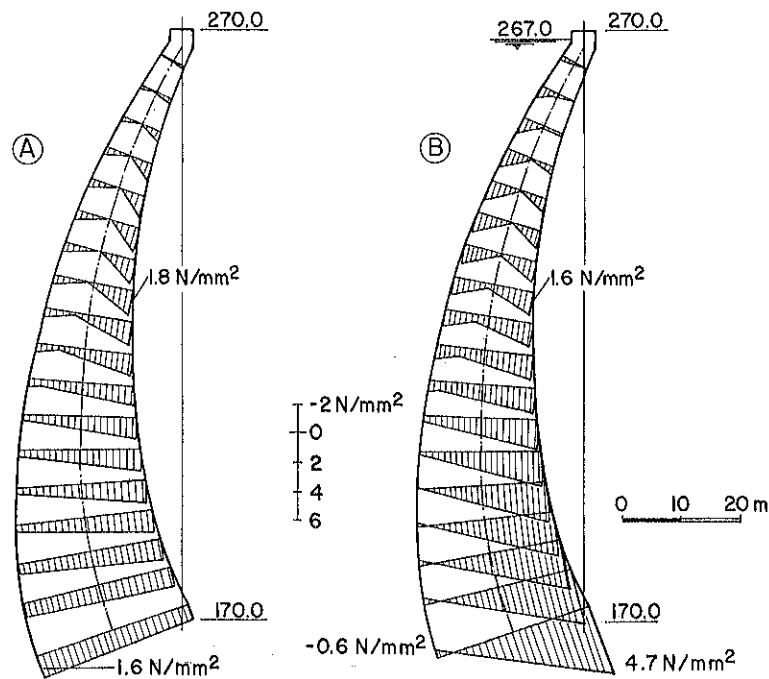
As an example, **Figure 6** shows the stress distribution in the crown cantilever after the completion of the grouting at summer time by empty as well as by full reservoir.

Fig. 6: Stress distribution in the crown cantilever after grouting of the cracks.
 (A) empty reservoir, during summer (B) reservoir at O.W.L. during summer
Distribution des contraintes dans la console centrale après injection des fissures
 (A) retenue vide, pendant l'été (B) retenue normale, pendant l'été

The structural analyses of the rehabilitated dam were therefore carried out by "freezing" the stress distribution existing before the grouting and superposing it to the stresses generated by the forces acting later on the monolithic structure. This results in a non linear stress distribution across the dam.

The grouting of the cracks must be carried out during the winter at reduced water level (January - March). In fact the low concrete temperature at this time leads to a downstream deformation of the dam resulting in a maximum opening of the cracks on the upstream face.

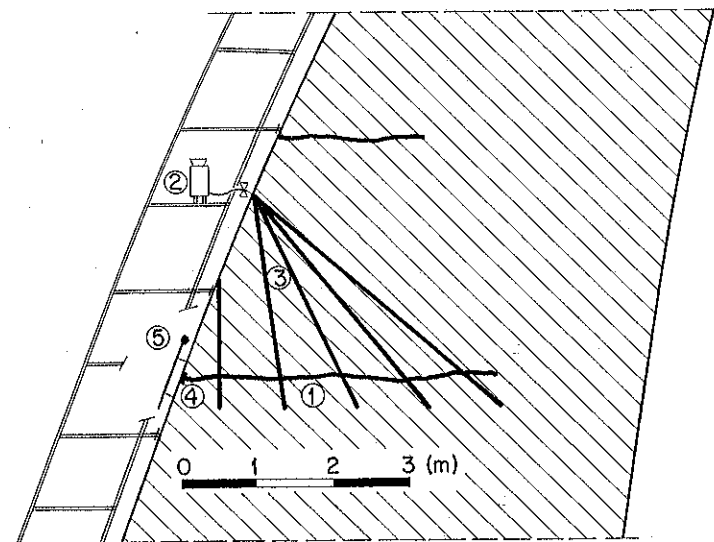
Fig. 7: Schematic lay-out of the boreholes and equipment.
Disposition schématique des forages et de l'équipement d'injection.

Then the extension of each crack was investigated by core drillings almost up to the downstream face. A videocamera introduced into the drillholes was used to detect the cracks as well as the frequent anomalies like honeycombs. All the groutholes required for the grouting were drilled in the following stage. The general lay-out of the groutholes is shown in **Figure 7**.

After completion of the drilling works the cracks were accurately washed. The remaining water and the fines were sucked up in order to dry as much as possible the concrete. Indeed the adhesion between the resin and the concrete is the better, the cleaner and dryer are the surfaces. Prior to grouting, the fissure on the upstream dam face was sealed using a synthetic mortar in which plastic pipes for checking and aeration were inserted. The grouting was then carried out in a single stage starting with the most inner holes and continuing toward the upstream face as schematically shown in Fig. 7.

The propagation of the grout was controlled in observing both the adjacent grout holes as well as the mentioned check and aeration pipes. The injection was stopped as soon as clear resin was flowing out of the pipes or became visible on the downstream dam face.

The pressures varied between a maximum of 60 bars at lower elevations to a minimum of 10 bars near the crest. The grouting pressure was kept as high as possible in order to insure an adequate penetration of the resin but still low enough to avoid any damage to the structure. An excessive grout pressure would have caused an additional extension of the cracks. As regards the grout volume the presence of voids and honeycombs in the concrete made its evaluation quite difficult as most of the injected resin was necessary to fill the voids rather than to seal the cracks.

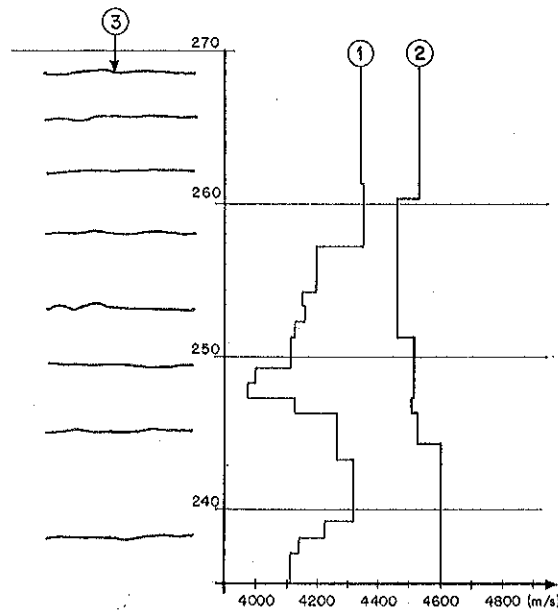
Figure 8 shows the improvement of the wave velocity and thus of the apparent over-all elasticity modulus achieved in grouting the cracks in the test block Nr. 17.

Fig. 8: Geophysical investigations in the test block Nr. 17.
Géophysique dans le bloc d'essai N° 17.
