Rehabilitation of the Flumendosa arch dam by epoxy grouting

Cracks in the upstream face of the Flumendosa arch dam in Sardinia, Italy, have recently been epoxy grouted to restore a monolithic structure. This article describes the reasons for the work and the grouting methodology followed.

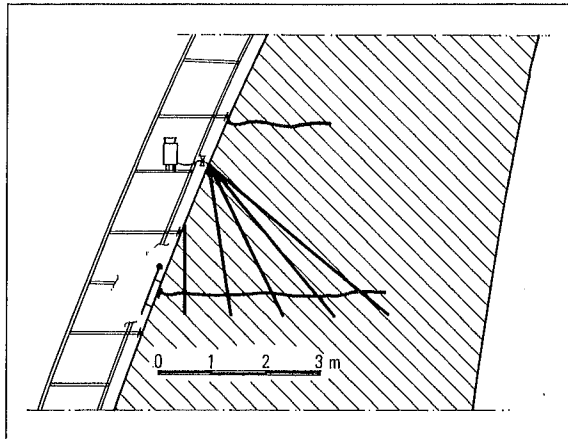
Fig. 3. The layout of a fan of holes crossing a single fissure.

Grouting was then carried out in stages for each crack, through a single inflatable packer placed in each hole about 1 m above the fissure, starting from the innermost holes and continuing towards the upstream face (Fig. 3 shows the layout of a fan of holes crossing a single fissure).

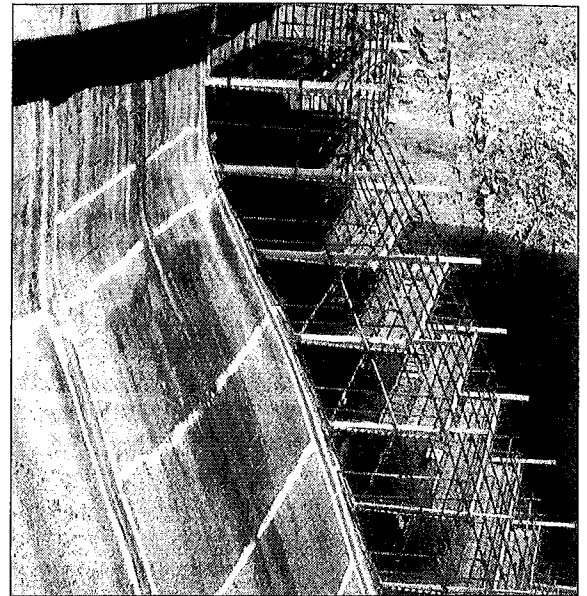
Erection of the scaffolding on the upstream face.

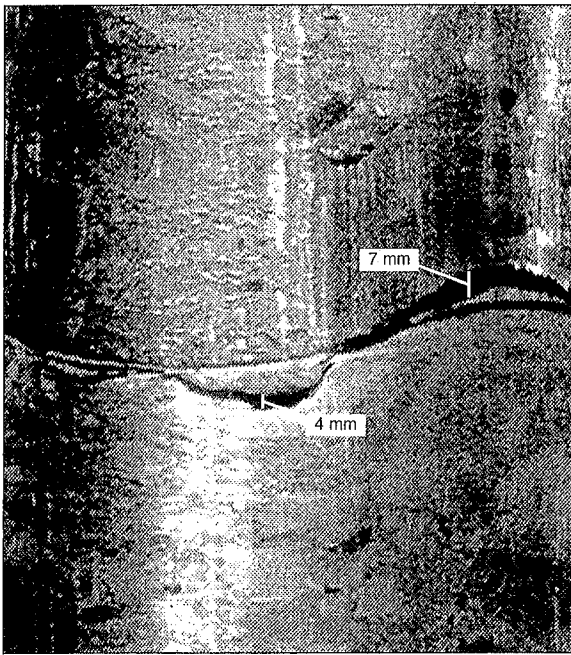
Picture 1. A typical crack recorded by video camera.

As a result, the geometrical features of each crack could be defined and plotted. 178 cracks, mostly sub-horizontal and for a total area of 7820 m², were detected and accurately recorded. The single crack surfaces varied from a minimum of 1.5 m² to a maximum of 123 m². Their open widths were in general about 2 mm, and occasionally up to 7 mm.

The video camera investigation, carried out on 4620 m of holes and registered on video cassettes, also showed a high number of honeycombs, up to 100 mm thick, mostly above the lift surfaces.

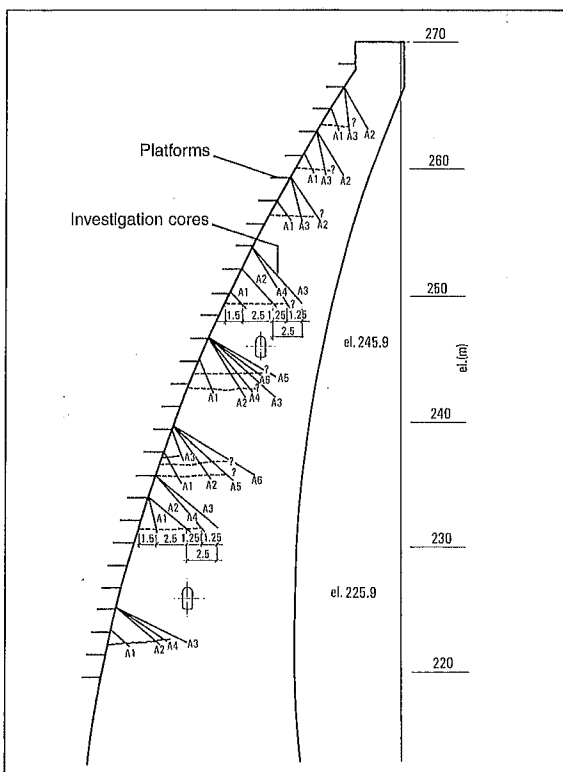
Fig. 4. Cracks detected in one block (VIII) of the dam.

The grouting treatment was progressively carried out in each of the 24 blocks of the dam, corresponding to all the cracks which had been recorded, starting from the deepest elevations upwards.

For each crack, the grouting was done, starting from the deepest holes in the central area of the block, and continuing progressively through the adjacent holes towards the lateral joints and the upstream face, with the aim of reaching the design pressure.

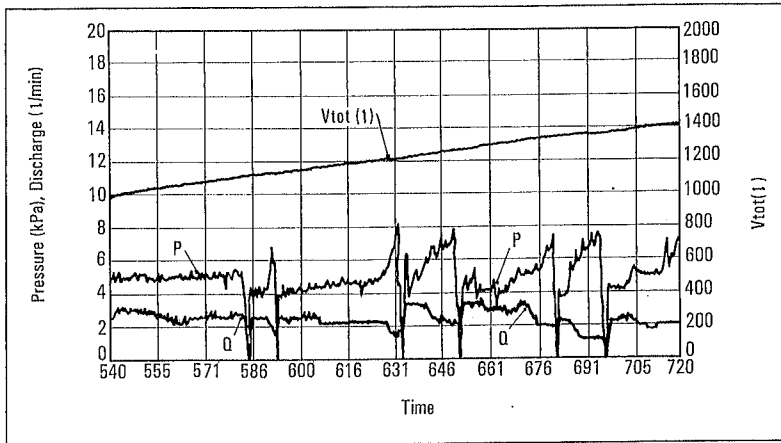
Fig. 5. A graph obtained by the PAGURO® system, measured in real time, which plots the resin flow rate (Q), the quantity of injected resin (V_{tot}) and the pressure (P) applied.

Fig. 5 is an example of a graph obtained by the PAGURO® system. This system is able to take measurements in real time, and can plot the rate of flow, the quantity of the injected resin as well as the pressure applied.
