REHABILITATION OF THE LANGETENTAL FLOOD DIVERSION TUNNEL

Roger BREMEN
Engineer of the Hydraulic Department

Lombardi Engineering Limited
Via Simen 19
CH – 6648 Minusio
Switzerland

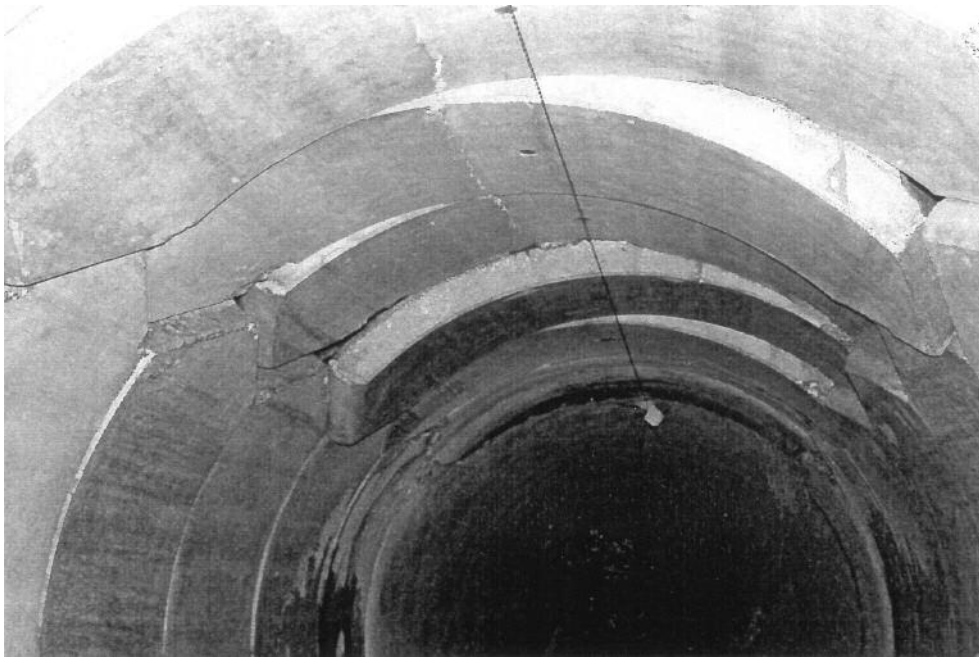
After the flood, the inspection of the tunnel revealed extensive damages on the lining. In particular as shown in Figure 3 more than 120 roof segments were displaced vertically up to 15-20 cm. Furthermore evidence of the Leka filling material wash-out could be observed at several locations leaving voids above the lining and disclosing locally the excavated rock. Despite relevant dislocations, no roof segments were completely failed out of their position. To mention that no connections were provided between the segments.

Figure 3: Typical damaged zone after the flood event

This pulsating action combined with the presence of a granular, non-cohesive and highly compressive filling material, and the absence of any connection between the segments has resulted in the possibility of the roof segments to move in a vertical direction. After the joints between the elements have been opened, the granular expanded clay could easily be washed-out by the flow leaving voids behind the roof segments. In other terms, the segments and the filling material behind were unable to withstand the dynamic action of the flows which in this case due to the particular tunnel configuration are particularly relevant.

- Repositioning of the displaced segments and, where required, repair of the damaged parts.
- Consolidation of the granular expanded clay filling material using a cement grout mix.
- Improvement of the flow conditions in the dissipation chamber at the bottom of the intake shaft with the purpose to insure a proper flow desaeration and energy dissipation.

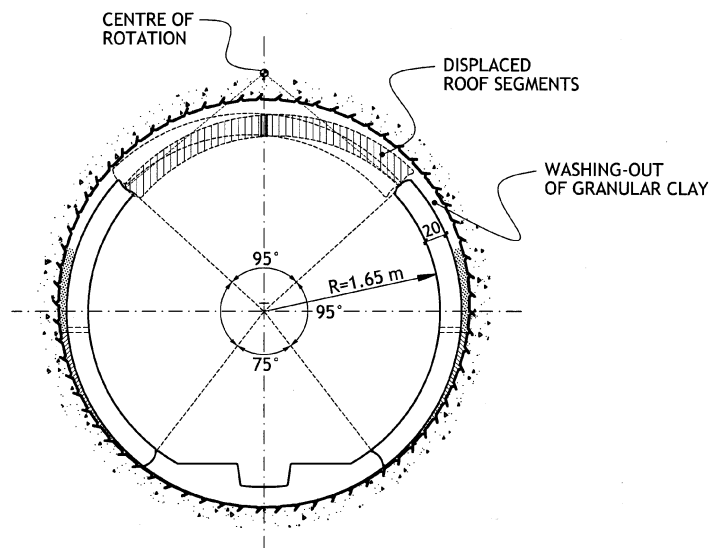
The schematic position of the roof segments is shown in Figure 4. To be noticed that at any damaged location the segments displacements were alternated upward and downward with nearly no displacements at the top of the section. As shown in Figure 4 a rotation centre could be identified above the tunnel crown.

Figure 4: Schematic alternating displacements of the roof segments

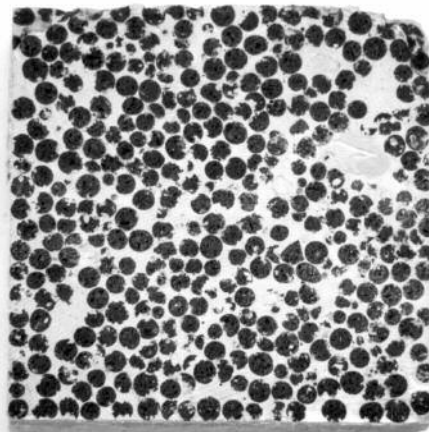
As shown in Figure 5, preliminary laboratory investigations revealed that with an adequate procedure, the grouting of the granular clay was generally possible at relatively low grouting pressures. Difficulties were expected in the presence of a high percentage of fractured spheres since the permeability of the filling material is then reduced.

Figure 5: Results of a successful grout test of the granular expanded clay (laboratory test)

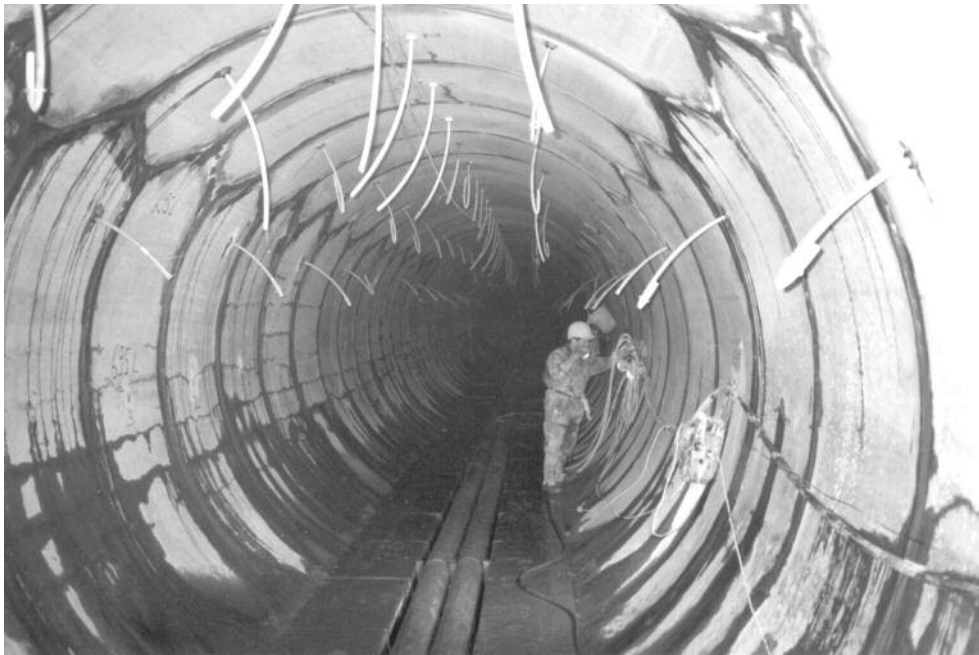
Figure 6: Progress of the grouting works without any mixing plant in the tunnel.

After the relocation and repair with mortar of the damaged segments, grouting holes were drilled in the upper half of the tunnel lining. After the drilling works, all the joints between the segments had to be sealed with mortar in order to avoid any grout escape. In total nearly 14 km of joints were sealed within 3 months.

The grouting was carried out using a fine Rohrbach Cement (H50) with Blaine values of approx. 7000 cm²/g. A grout mix with a Water Cement ratio of 1.0 and the addition of 2% bentonite was used resulting in a highly stable and relatively fluid grout mix. Figure 6 shows the tunnel during the grouting works.

As regards the grouting installation, no equipment could be installed in the tunnel in order that an innovative solution was required. Following the evaluation of various alternatives it was decided to prepare the grout in two permanent plants from which high pressure pipes conveyed the mix up to the grouting front. Pressure relieve valves and parallel grouting at various holes allowed to control the grout pressure at the injectors and avoid any clogging of the feeding pipes. To mention that the piping system allowed to reach distances of up to 3.5 km between the main plant and the grouting front.
