CASE HISTORIES OF CONCRETE DAMS (Structural Cracks)

Structural Safety Assessment of Dams

CISM - Udine 14th December 2004

presented by Dr Eng. Giovanni Lombardi

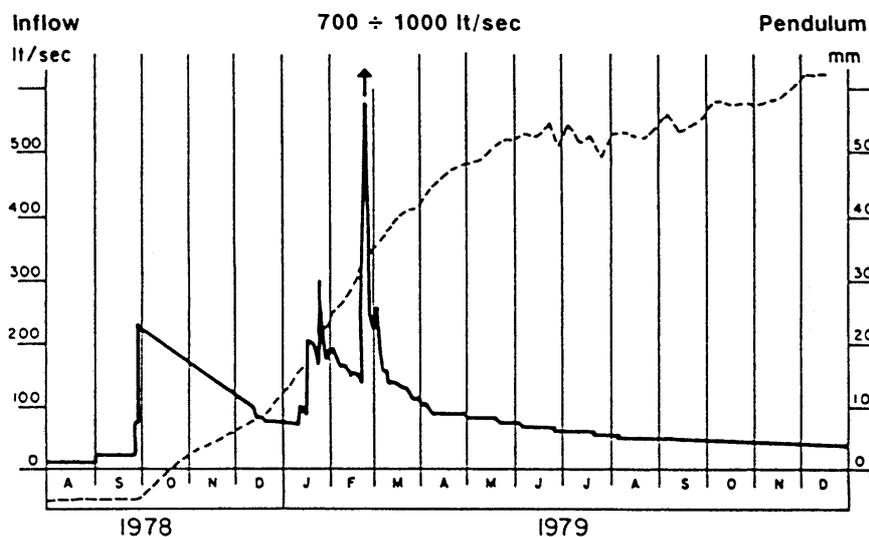
With time however, said relationship was clearly confirmed, as can be seen on **Figure 3**, which did convince of the reality of the phenomenon envisaged. Indeed the settlements could be correlated with the inflow rate in the adit.

Figure 3: Zeuzier dam. Inflow in the exploratory adit ①, upstream displacement shown by the central pendulum at crest elevation ②, and water volume inflow ③ as integral of ①.

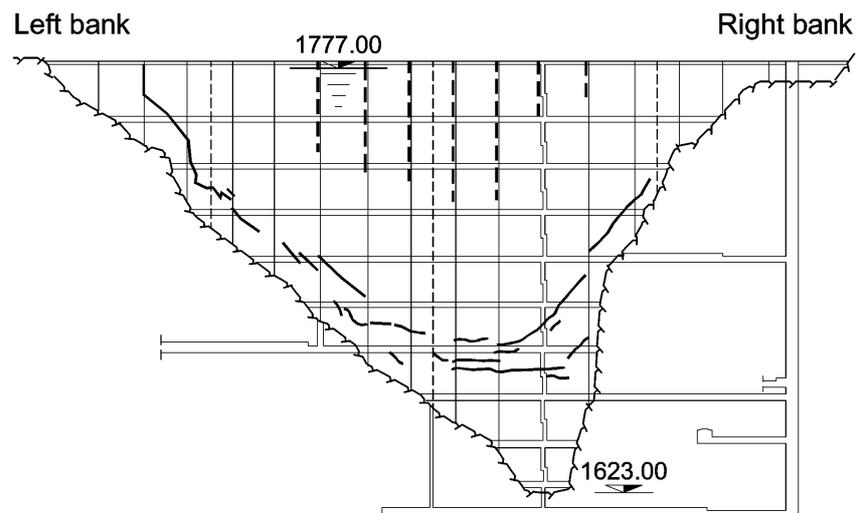
Meanwhile, the movements went on, while the reservoir was kept at low level. The settlement at the valley bottom reached finally about 13 cm, the valley itself was narrowing by 7 cm and the crest at the dam axis moved 12 cm upstream. Im-

portant cracks, up to 15 mm wide, formed on the downstream face of the dam and contraction joints opened on the upstream one (**Figure 4**).

Figure 4: Zeuzier dam. Main cracks on December 1980 (openings above 1 mm; max. 15 mm); upstream joint openings = dashed lines; downstream cracks = solid lines.

In the years 1982/1983, as the movements did slow down, the dam could be repaired by grouting the cracks in the dam with epoxy resin and in reinforcing the grout curtain along the foundation line.

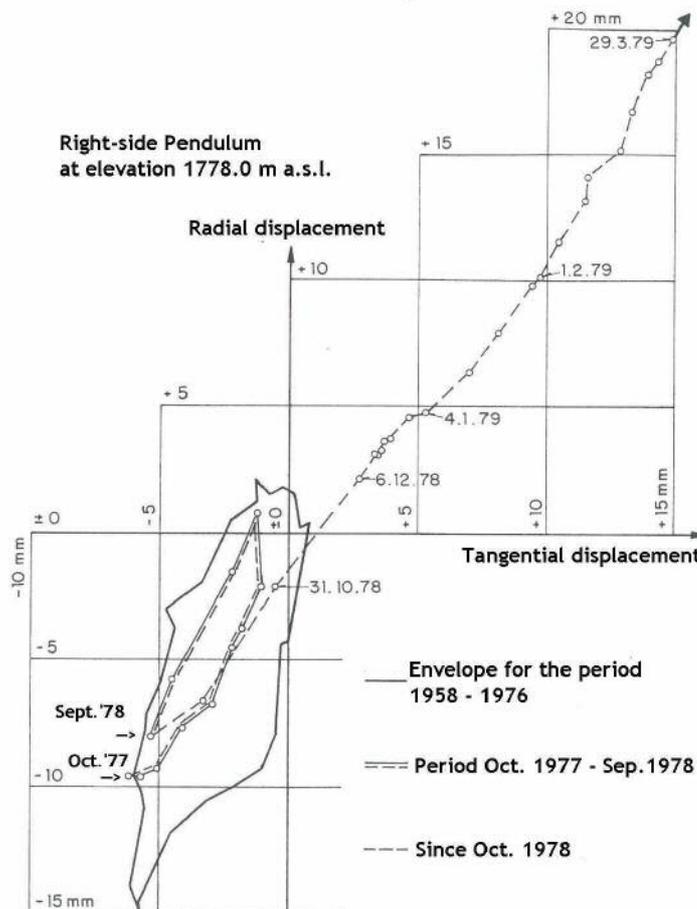
Figure 5 shows the displacements of the crest detected by the right-side pendulum in the last months of 1978 and the first ones of 1979 in relation with the envelope reached by the readings in the period 1958-1976.

During September 1978 the line of the displacements changed sharply its direction; crossed about the 10th of November said envelope and went on at a speed of about 5 to 7 mm a month.

A modern interpretation of the readings would have allowed to be warned already at the end of September 1978 that is 4 to 5 months earlier, as can be understood from figure 5.

Figure 5: Radial and tangential displacements of the right side pendulum at crest elevation.

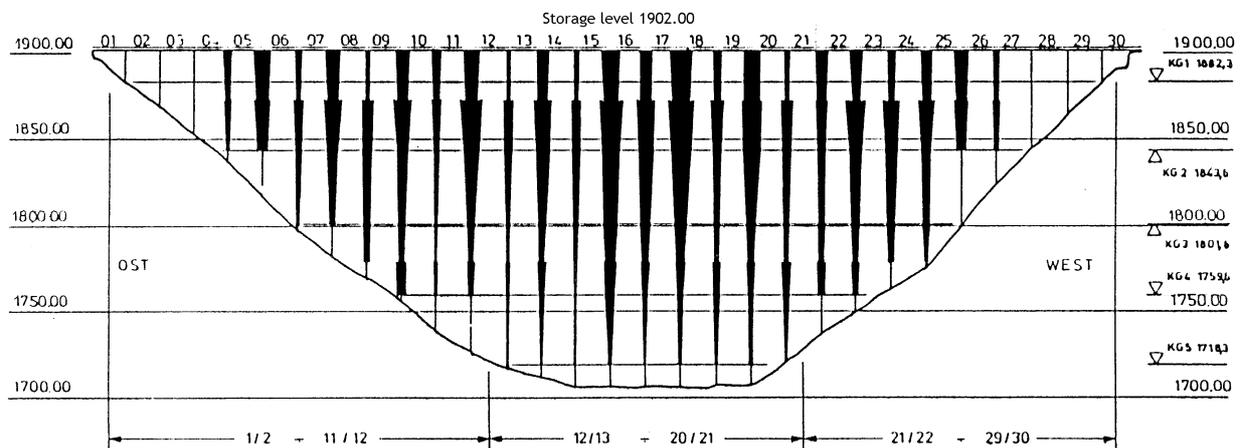
Figure 11 shows the opening of the joints produced by the grouting process.

Figure 11: Kölnbrein dam. Opening of the contraction joints due to intense grouting.

The steps in the openings are due to the fact that the grouting was carried out in various stages; that is one stage after each of the three periods of concreting at summer time and an additional campaign at the end.

The alternance of wider and less open joints is due to the sequence of the grouting stages along the arches.

The joint openings at crest elevation did sum up to about 400 mm.

This elongation of the crest produced obviously a deflection to upstream and especially a strong bending near the foundation of the concrete blocks.

The bending produced tensile cracks at the downstream heel, sometimes along the rock-concrete contact, sometimes in the rock itself, sometime finally along the joints of the concrete lifts.

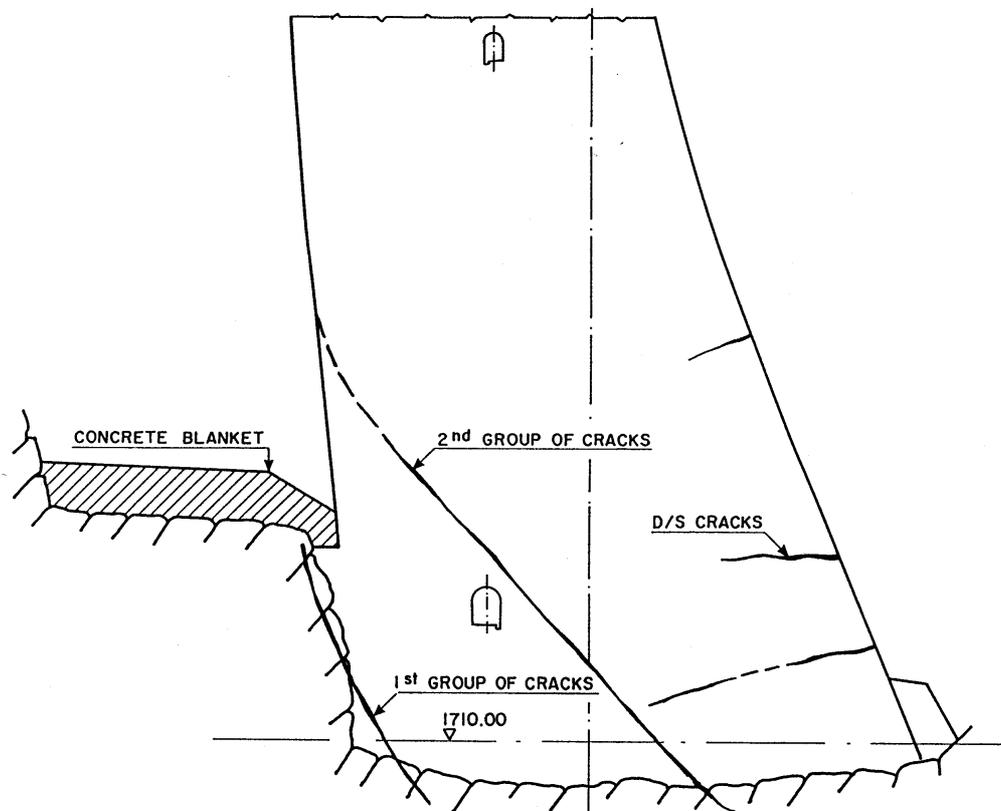
The first impounding at Kölnbrein induced, as normally, strong transverse forces in the zone of the already fissured blocks. According to **Figure 12** the residual non-fissured upstream part of the cross section could not resist said forces. Tensile inclined cracks did develop and the dam slid on its foundation for a few centimetres.

We may observe the difference of two types of cracks, the upstream and the downstream ones.

These last are due to bending moments and thus started perpendicularly to the dam face and developed towards the inner dam body.

At the contrary, the upstream ones had to start from inside the dam and daylighted on the face forming quite a small angle with it.

Figure 12: Kölnbrein dam. Typical cracks in the dam blocks.

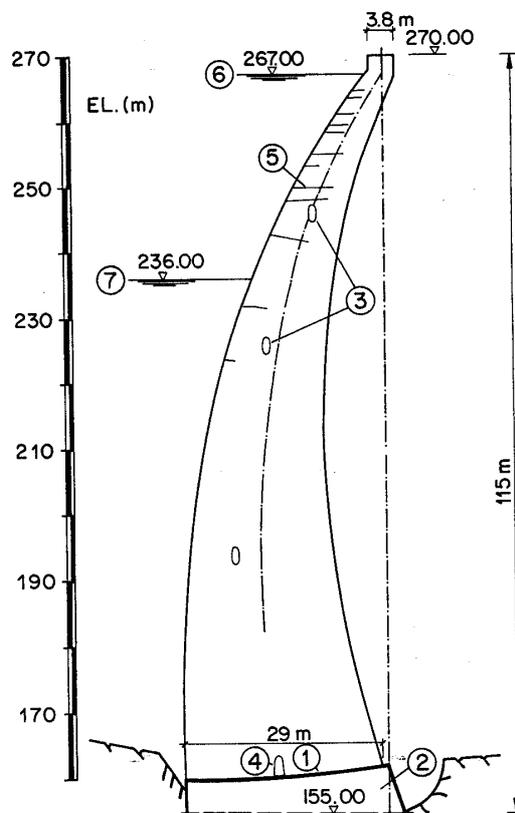
Already at the end of the construction period and immediately after its completion a great number of horizontal cracks did appear on the upper part of the upstream face, as can be seen on **Figure 15**.

Figure 15: Flumendosa dam. Cross section at the crown.

As the necessity arose to increment the water storage, various investigations were carried out, which confirmed the crack pattern shown at the same figure. Very often the cracks did follow the lift joints in the concrete, as obviously the same were offering the lowest tensile strength.

The extent of the cracks from the upstream face was increasing from the crest level to a maximum of about 60% of the dam thickness at a point located 15 to 20 m below the crest and decreasing again towards lower elevations.

Due to the strong downstream overhang of the upper part of the dam, the cantilevers are not stable by themselves and need a support from the arches.

To ensure that action the contraction joints had to be grouted stepwise during concreting; that means before the hydration heat could dissipate and the concrete could cool down. The subsequent cooling of the upper arches deprived the cantilever from their support. So, they deflected to downstream and the cracks did form due to the bending moments induced.

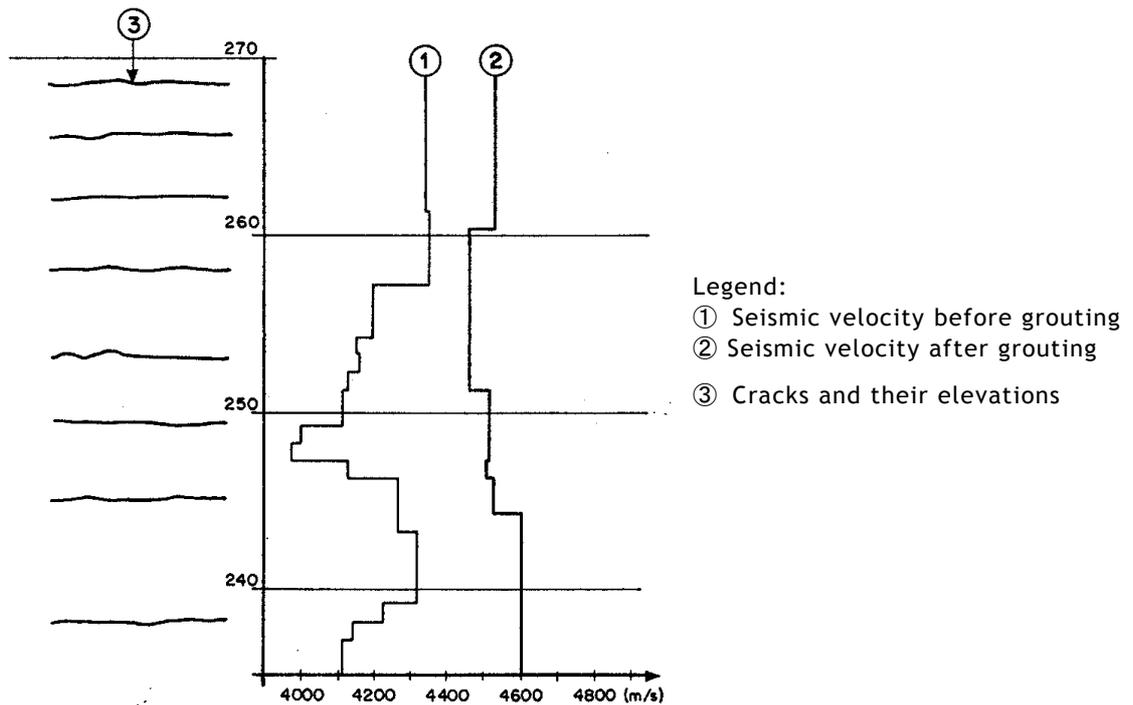
The grouting was very successful as the seismic velocity was significantly increased and uniformised as can be seen from **Figure 18**.

Figure 18: Geophysical investigations in the test block Nr. 17.
