THE 2001 GOTTHARD ROAD TUNNEL FIRE

Tunnel Management International

Volume 7, Number 1, 2004 pp.33-39

A. Henke, Lombardi Engineering Ltd, Minusio, Switzerland

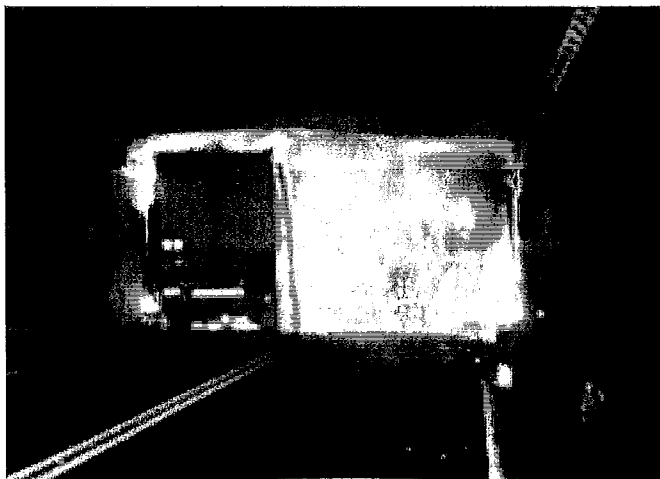
The origin and the development of the fire have been abundantly reported in press releases, in several technical papers (see references) and in reports of the public prosecutor. In summary, there was a head-on collision of two trucks, the ignition of spilled diesel fuel and the rapid spreading of the fire to a truck loaded with tires and to other vehicles which were blocked at a relatively close distance to the accident (see Figures 1 and 2).

Figures 1-2: Scene of the Gotthard tunnel fire moments after the rescue teams arrived from the south portal.

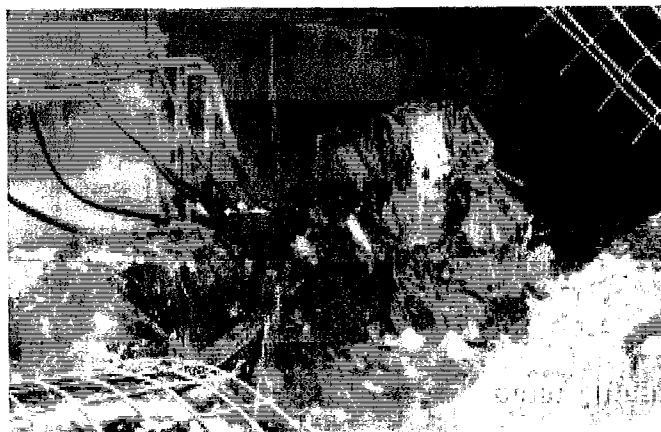
More important than the heat, from a point of fatalities, was the smoke production. It developed nearly as quickly as the heat. The combustion of the tires was the main source of smoke (see Figure 3). It produced a black, dense and poisonous smoke, which moved to the northern side, respectively, inside the tunnel. Although the ventilation system reacted quickly, worked properly and ensured that no smoke spread to the southern, portal-near side, it was not able to extract all of the exceptionally large amount of smoke moving to the north.

Figure 3: Remains of the burnt tires.

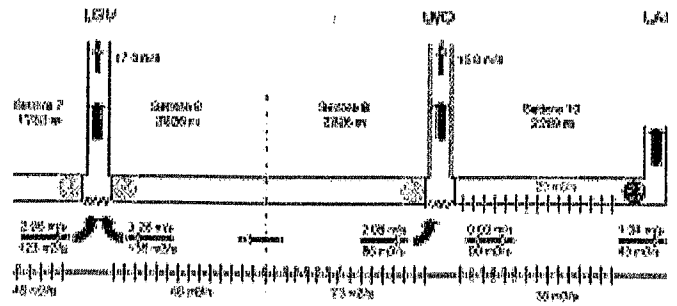
The exhaust fans involved were reset from the initial reduced semi-transversal regime (see Figure 5) to full operation between 4 and 6 minutes after the beginning of the fire. Because of the extremely rapid development of the fire, it was unavoidable that the smoke spread towards the north side before the full exhaust rate had become effective. A distance of 500 m north of the fire, where most of the fatalities occurred, the smoke arrived about 4 minutes after ignition, still enough time for some users to turn their vehicle around and leave the tunnel or get to a safe place, but too short for some unaware users who waited and did not realize what was happening further along the tunnel.

Figure 5: Air flow in the tunnel immediately before the fire (09:41:27).

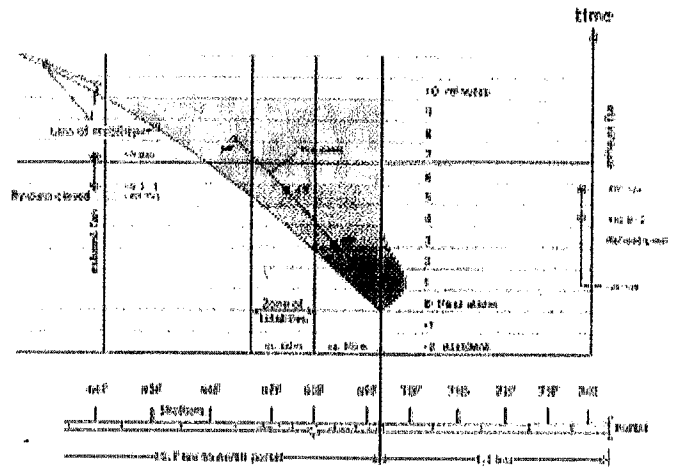
One has to consider that the tunnel air extraction occurred uniformly through regular openings in the ceiling, since the new smoke extraction system operated by motorized dampers was not yet fully installed at that time. Figure 6 shows a plot of the propagation of the smoke as best deduced from the data of the various control equipment. An accurate analysis of the balance of the air flows during the fire showed clearly that the northbound drift was considerably amplified by the predominant piston effect of the traffic, 38% of it heavy vehicles, evacuating the 16 km long northern part of the tunnel.

Figure 6: Plot of the propagation of smoke.

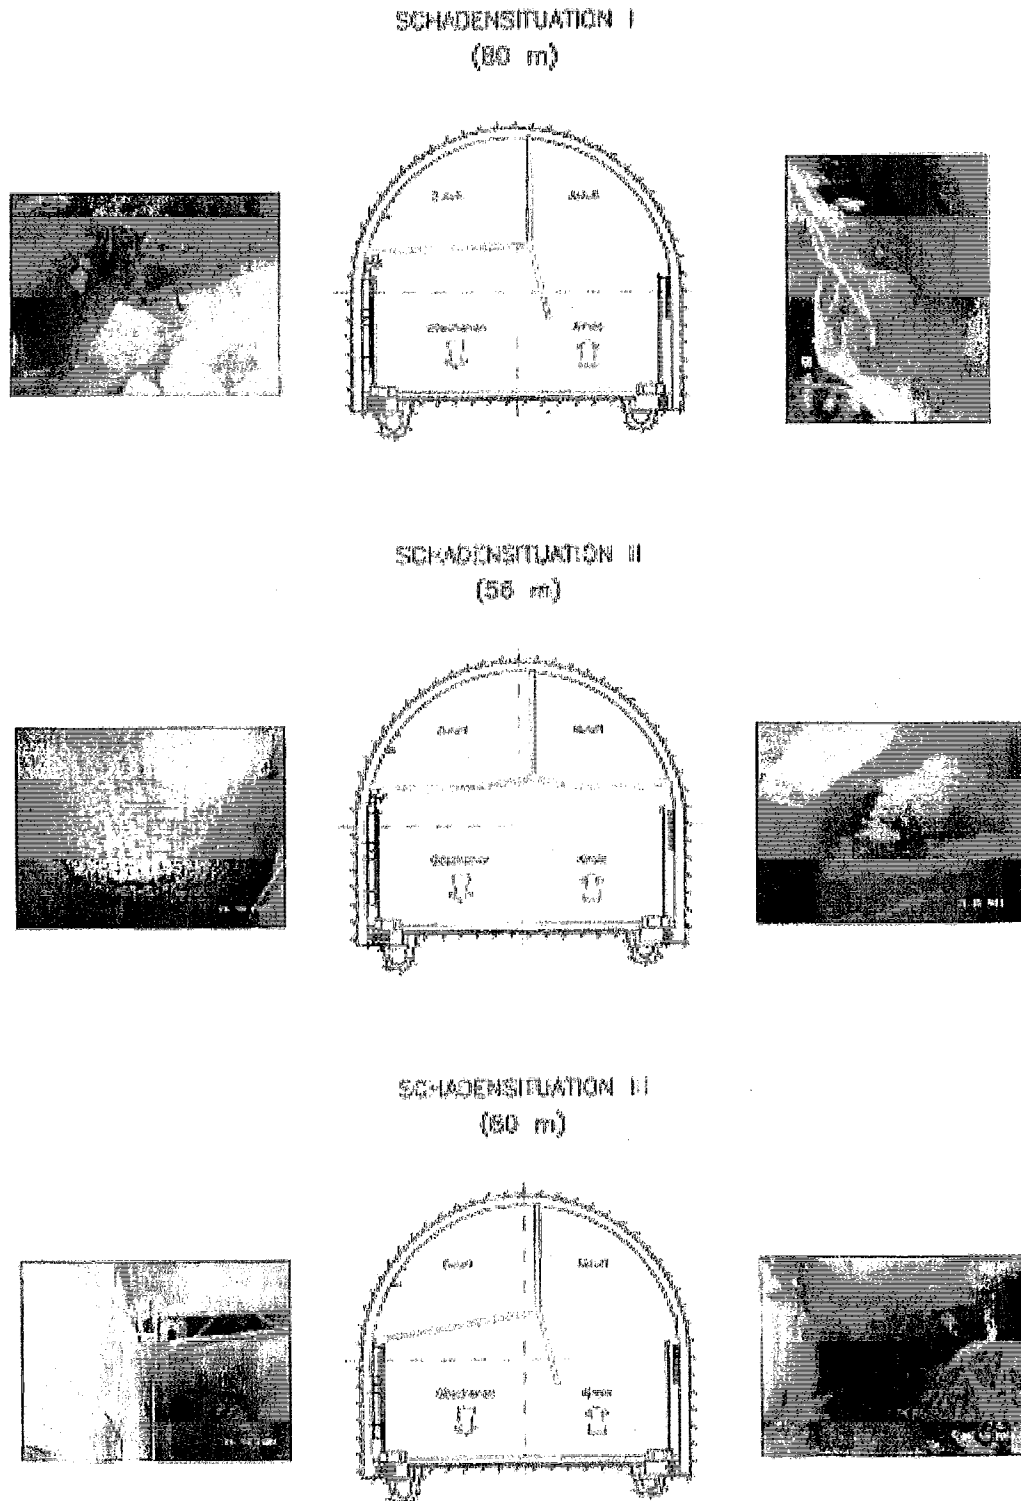
Shortly after the fire, following a first inspection by the structural engineer, one could identify a zone of 230 m of length where the intermediate ceiling had collapsed or showed severe damage. This was defined as the 'red zone' where no access was allowed prior to structural support measures. Beyond that zone, structural damage was limited, but the electromechanical equipment was destroyed. This extended zone was 750 m long. A thick black smoke deposit, which covered all surfaces and stranded vehicles, extended over more than one kilometer from the fire.

Typical damage patterns of the intermediate ceiling, over the 230 m, where 7 trucks burned out completely, are showed in Figure 7. In the northern part, the side of the slab towards the exhaust air – over the burning trucks – collapsed, whereas the other side presented surface damage. In the central part measuring 56 m and with no vehicles, the ceiling did not collapse, but exhibited great deformation, cracks and extended concrete spalling. In the southern part, where the fire initiated, both halves of the ceiling collapsed, but on one side it did not fall down onto the road, but was just held up by the lateral secondary prefabricated lining.

Figure 7: Ceiling damage patterns found in the 'red zone.'

- The vertical dividing wall in the crown, and especially the integrated suspension bars, resisted with no remarkable reduction of the mechanical properties. Whereas the ceiling had to be entirely replaced for the whole length of the red zone, the wall has been neatly fitted at the lower end and could stay in place.

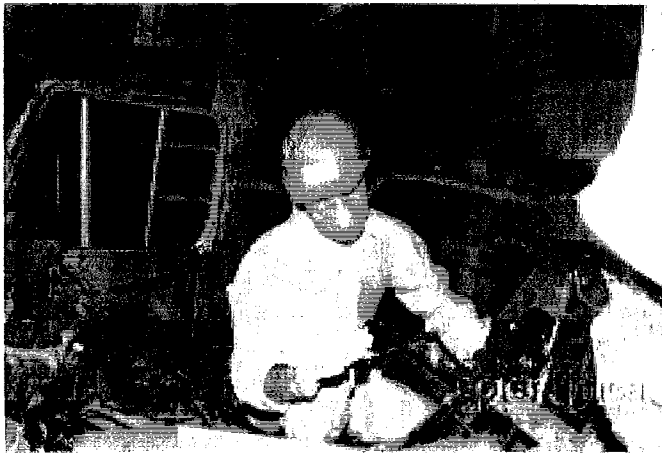
The short time factor, when planning the repair works, was very difficult. One had to face unforeseeable activities and restricted accessibility to the damage zone—blocked by destroyed vehicles and debris from the damaged structures. Furthermore, there were limitations imposed by the forensic police and by specialists in charge of monitoring and evaluating the contamination and pollution prevention (see Figure 8).

Figure 8: Debris of the destroyed vehicles had to be left untouched in order to allow examination by the forensic police.

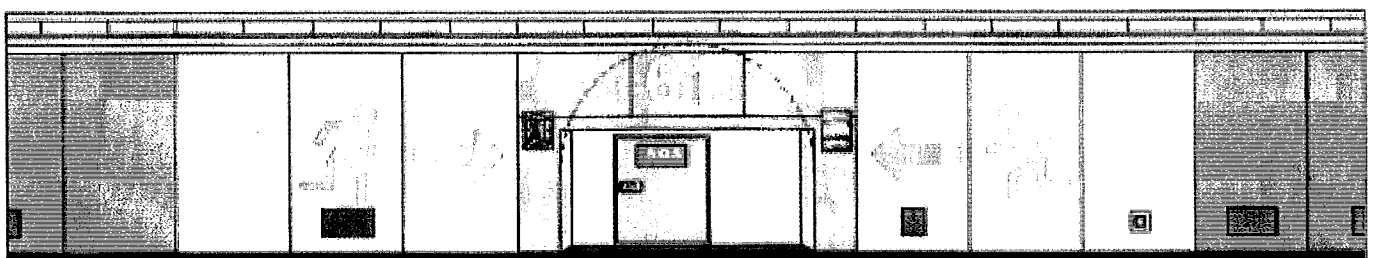
Figure 14: New layout of the shelter entrances.

- signs every 50 m inside the tunnel, which indicate the distance and direction of the nearest shelter (already installed).
- highlighting, with white and green color, the shelters' entrances (in progress, see Figure 14).
- information panels inside of the shelters (already installed).
- installation of a reinforced illumination and flashlights at the shelters' entrances (in progress, see Figure 14).
- installation of light spots along the side walks (in progress).
- automation of the radio information in four languages in case of a critical event.
- communication with the shelters by means of loud-
