REPAIR WORKS AT FLUMENDOSA ARCH DAM (*)**R. SILVANO***Project Management**Ente Autonomo del Flumendosa***F. FRONGIA***Project Management**Ente Autonomo del Flumendosa***A. MONDADA***Head of structural analyses department**Lombardi Engineering Ltd.***A. PIAZZA***Design Engineer**Lombardi Engineering Ltd.***ITALY****1. INTRODUCTION**

The 115 m high double curvature arch dam of Nuraghe Arrubiu on the Flumendosa river, owned by the "Ente Autonomo del Flumendosa" of Cagliari in Sardinia, was completed in 1957 after a 5 years construction period. The dam is part of an extensive drinking water and irrigation system of the the city of Cagliari and shows an active storage capacity of nearly $300 \cdot 10^6 \text{ m}^3$. Already at final construction stage and immediately after its completion, a great number of cracks appeared on the upper part of the upstream face. As consequence, for nearly 40 years the reservoir was impounded only partially with a maximum water level 31 m below the design level and a $\frac{2}{3}$ loss of its storage capacity.

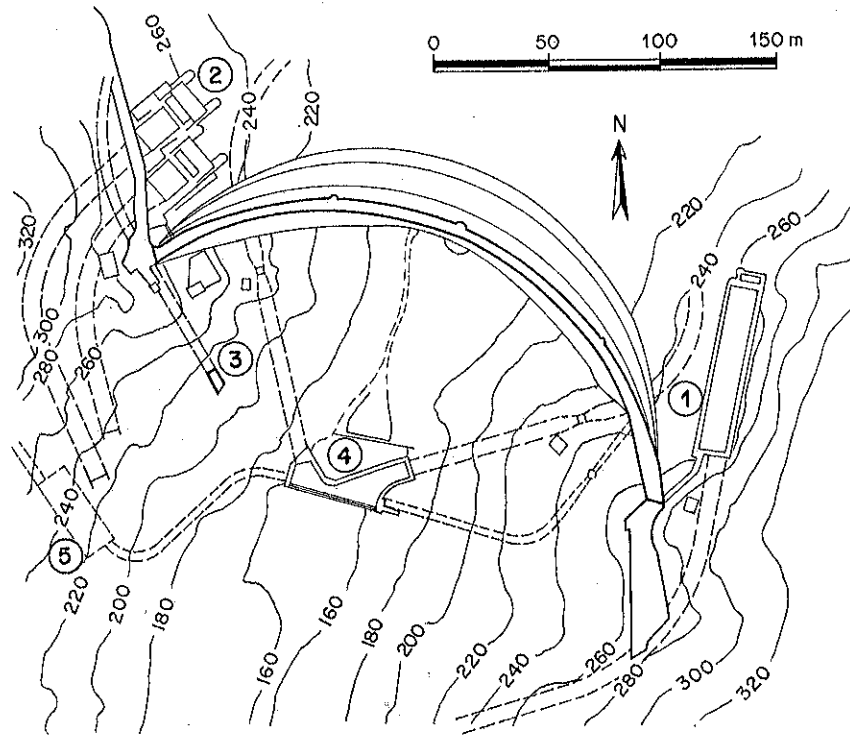
Fig. 1: General layout of the Flumendosa arch dam and its ancillary works.
Plan général du barrage voûte de Flumendosa et de ses ouvrages annexes.
