REHABILITATION OF THE LANGETENTAL FLOOD DIVERSION TUNNEL

Roger BREMEN
Engineer of the Hydraulic Department

Lombardi Engineering Limited
Via Simen 19
CH – 6648 Minusio
Switzerland

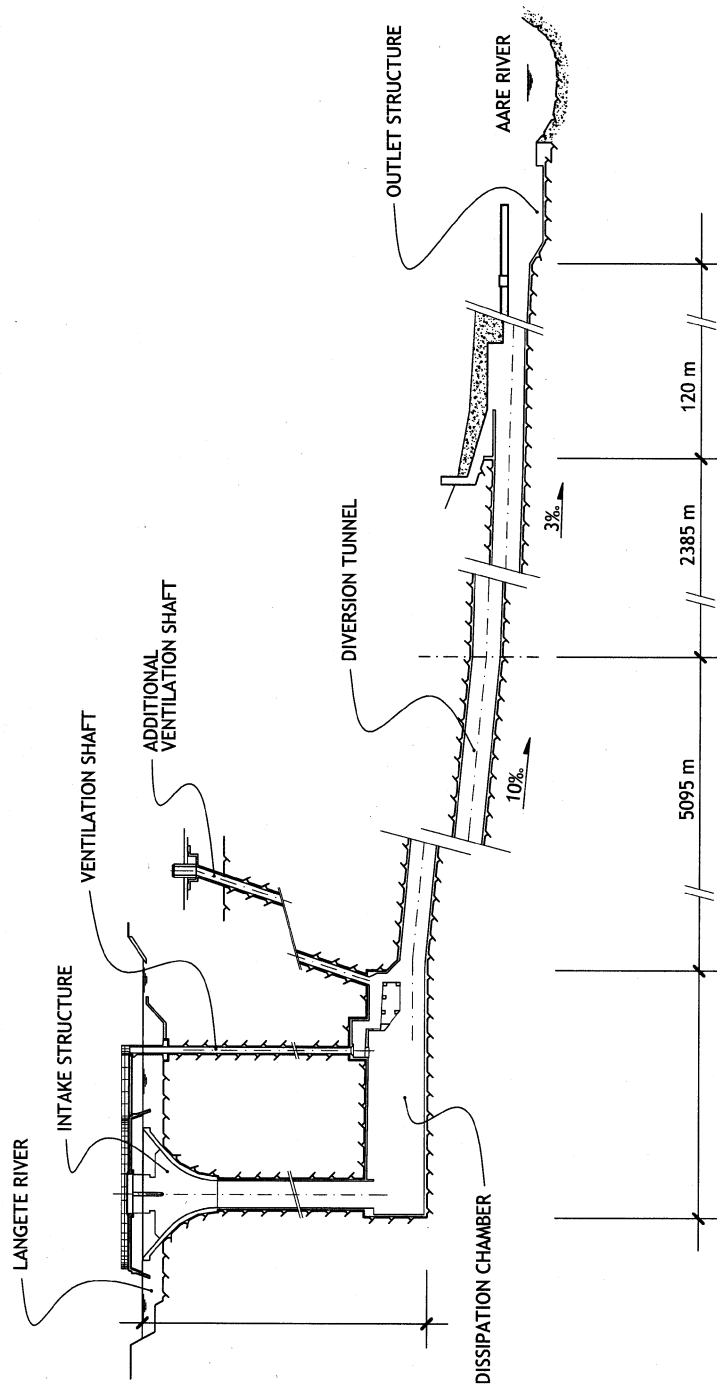
Figure 1: Schematic longitudinal profile of the Langeten flood diversion project.

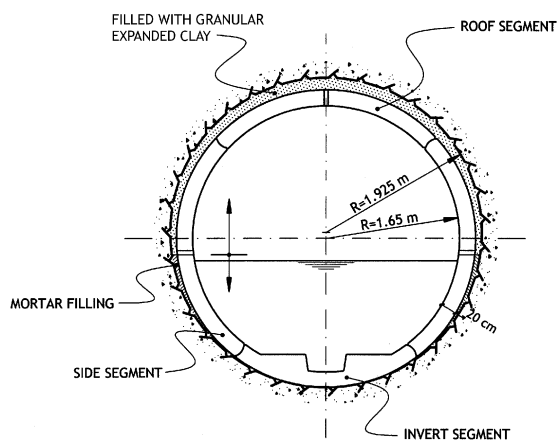
Figure 2: Typical cross section of the Langeten flood diversion tunnel

As shown in Figure 2, the two lateral segments were equipped with one horizontal hole from which the lower part of the gap between the lining and the rock was filled with conventional cement mortar. The gap of the upper half section was filled from the opening in the roof segment. As filling material granular expanded clay (Leka) was used with grain sizes between 0.3 and 0.6 cm. This highly compressible material was inflated from the opening in the roof segment.
