CASE HISTORIES OF CONCRETE DAMS (Structural Cracks)

Structural Safety Assessment of Dams

CISM - Udine 14th December 2004

presented by Dr Eng. Giovanni Lombardi

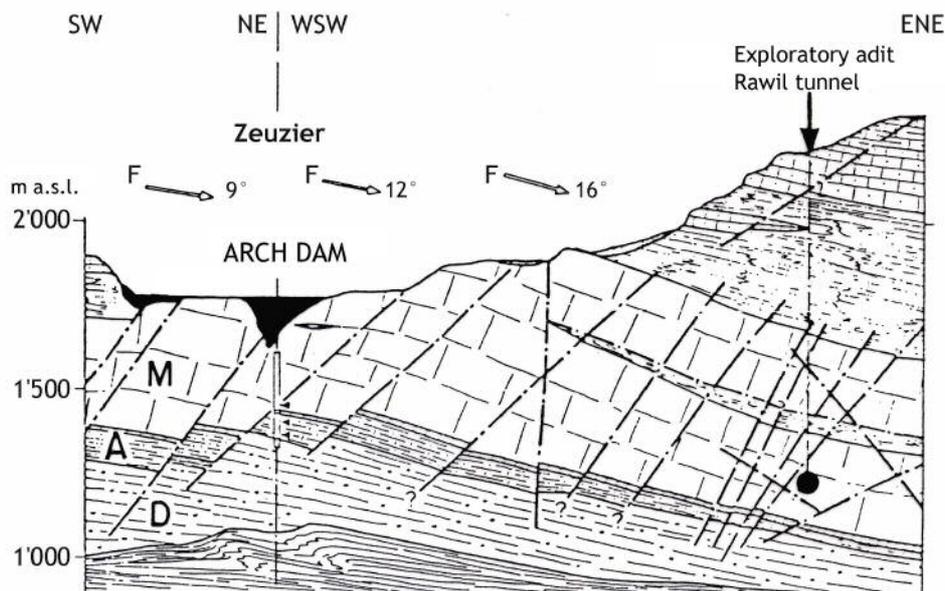
The dam is resting on a sound, thick zone of Malm-limestones as can be seen on **Figure 2**. These stiff limestone layers are subdivided by frequent fissures, so their permeability is high and practically no ground water is present in them. The site, deeply fitted in a strong rock mass, was correctly considered to be well suited for building a high arch dam.

However, below the limestones a confined groundwater aquifer did exist in the Dogger-formation protected by an aquiclude formed by a quite marly Collovian-Oxfordian rock layer.

Figure 2: Geological profile through the rock bar of Zeuzier extended to the exploratory adit. The dam is founded on the Malm limestone (M), below which is the Dogger formation (D). The two are separated by the Callovian-Oxford series (A).

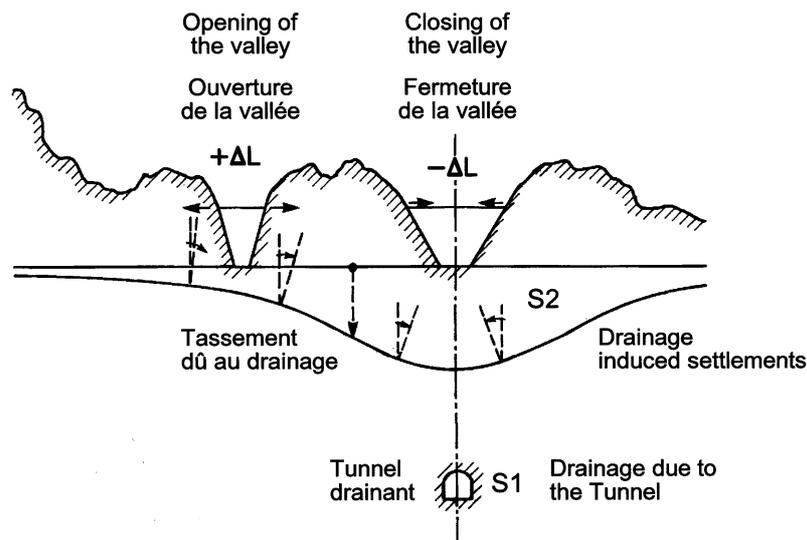
In a very schematic way the phenomenon can be qualitatively represented by **Figure 6**.

Figure 6: Opening and closure of the valley flanks due to the drainage during the tunnel construction.

While an overall settlement of the site has in itself little or no importance, the change in width of the valley may have heavy structural consequences, particularly in case of arch dams.

Depending on the geological conditions and on the position of the dam site respect to the tunnel, a widening or a narrowing of the valley can occur.

In fact, the settlements are due to the water being squeezed out from the joints and cracks in the rock mass, due to a reduction of the interstitial water pressure caused by the draining of the rock mass.

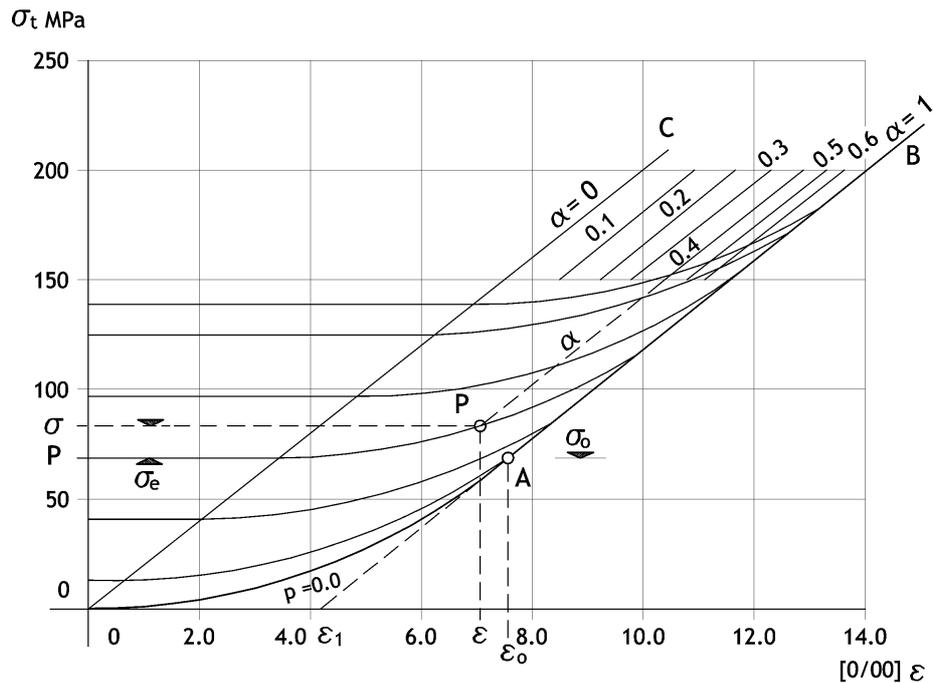
Figure 7 shows the model in the case of a single system of joints perpendicular to the compressive stress.

Each point P of the graph corresponds to a total stress σ , an interstitial water pressure p, a strain ε and a ratio α of closure of the joints. The right boundary of the plot, that is the line 0-A-B, represents the dry rock. It is easily understood that a reduction of the water pressure will shift the point P to the right and will thus cause a compressive strain, or a settlement.

Figure 7 : Example of a FES model of a rock mass:
 ε = strain; σ_t = total stress; p = neutral water pressure;
 α = degree of closure ($\alpha = 1$ fissures completely closed, $\alpha = 0$ fissures completely open); A (ε_0, σ_0) = point of total closure at nil water pressure; σ_e = effective stress;
 P ($\varepsilon, \sigma_t, p, \alpha$) = general strain, total stress, neutral pressure and closing ratio at point P.
 \Rightarrow effect of reducing the water pressure (drainage).

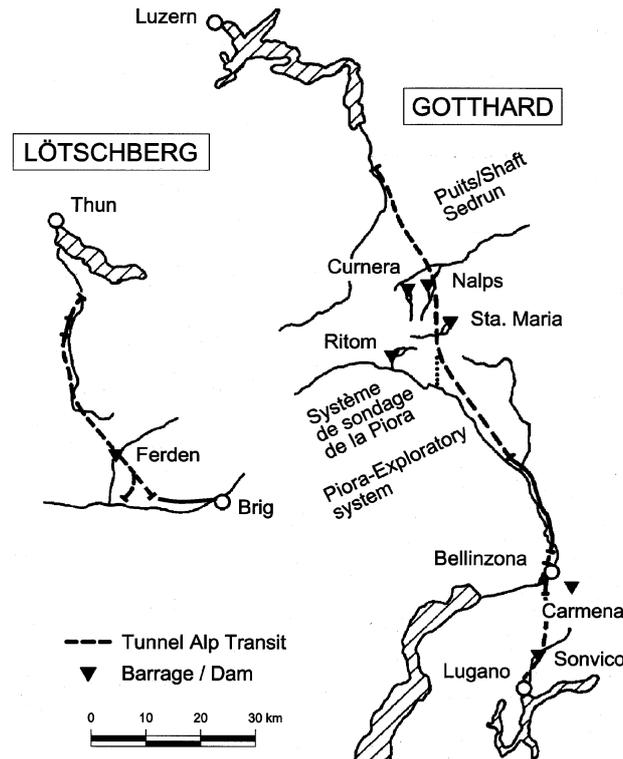
Presently two long high-speed railways tunnels are under construction in Switzerland as may be seen on **Figure 8**.

Figure 8: Dams in relation to the two tunnel projects.

Above them a number of dams exist. So the question of possible movements of their foundations cannot be ignored any longer and is presently analysed by 3-D Finite Elements Analysis based on the FES model as shown in Figure 9.

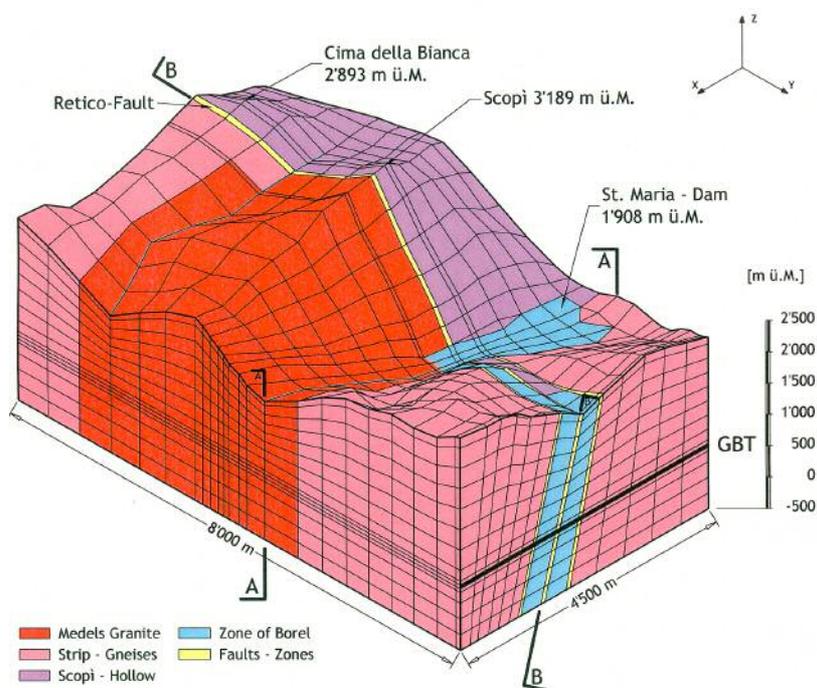
Figure 9: FES - Mesh for a stretch of the Gotthard AlpTransit Tunnel.

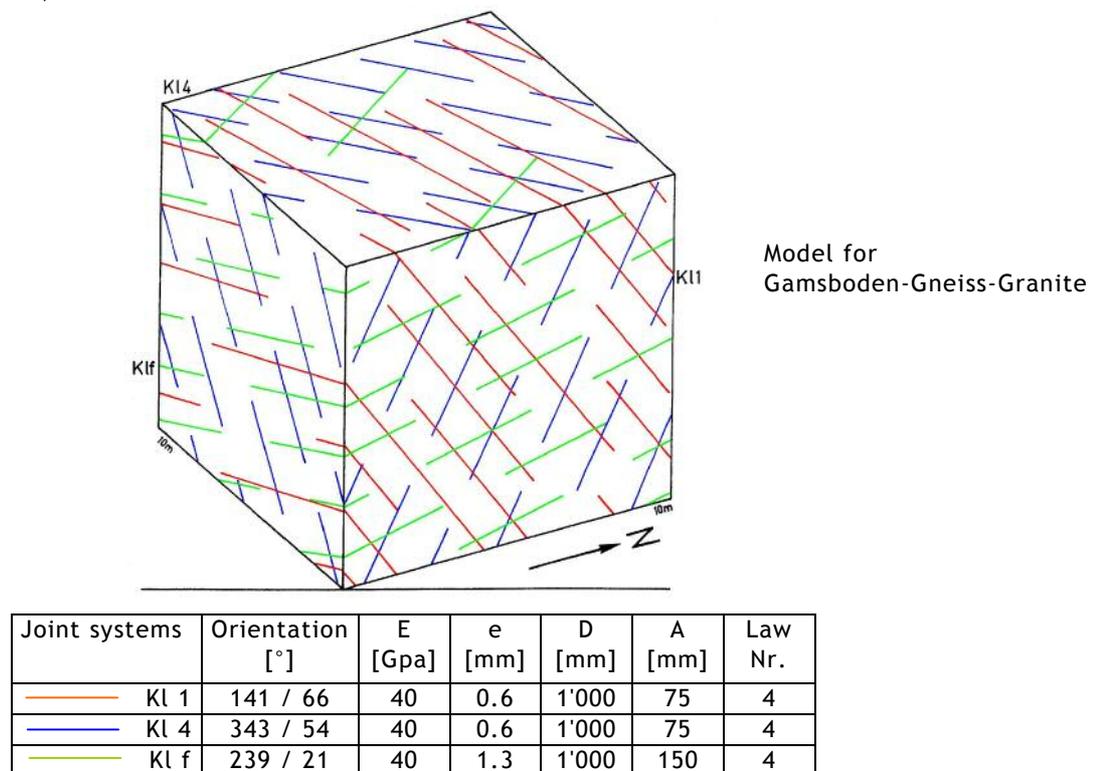
For each rock type and zone, a model of the joints configuration was set up (Figure 10).

Figure 10: Geologic block with assumed joint families with their orientation and characteristics.

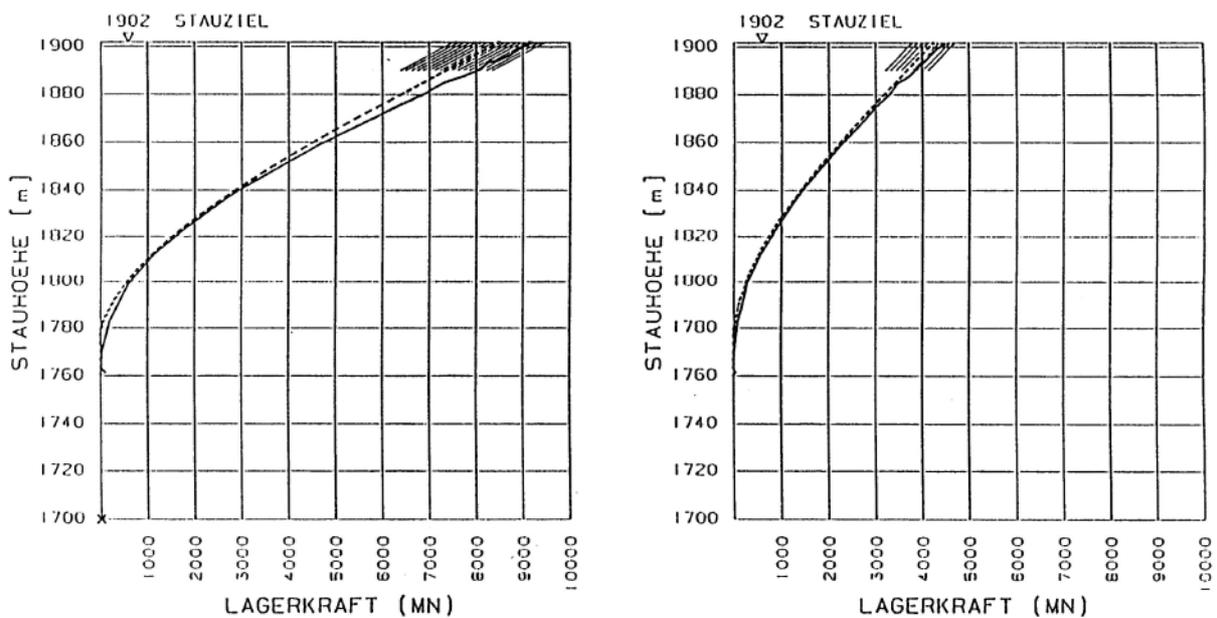
Finally, **Figure 14** shows the development of the total force transferred from the dam to the buttress in function of the water level in the reservoir.

The difference or error is only a small percentage of the maximum load.

Figure 14: Kölnbrein dam. Forces transferred to the buttress at the first impounding (1993). Total and central part of the dam.

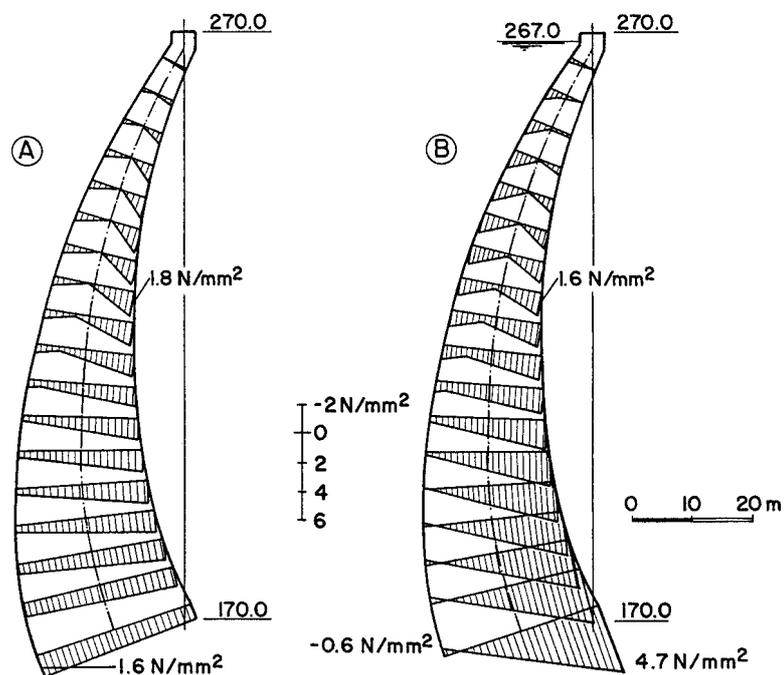
Figure 17 confirms this fact. There is for example a concentration of the vertical stresses near the faces and a reduction in the centre, which fact may be understood as a kind of advantageous pre-stressing in the vertical sense.

Figure 17: Stress distribution in the crown cantilever after grouting of the cracks. (A) Empty reservoir; (B) Reservoir at O.W.L. at summer time.

Obviously, the grouting did not fill only the cracks but also all the voids present in the concrete.

Indeed, 75'000 kg of resin were injected to treat a surface of 13'000 m² of cracks. This means an average thickness of 5 mm, which is much higher than the actual opening of the cracks.

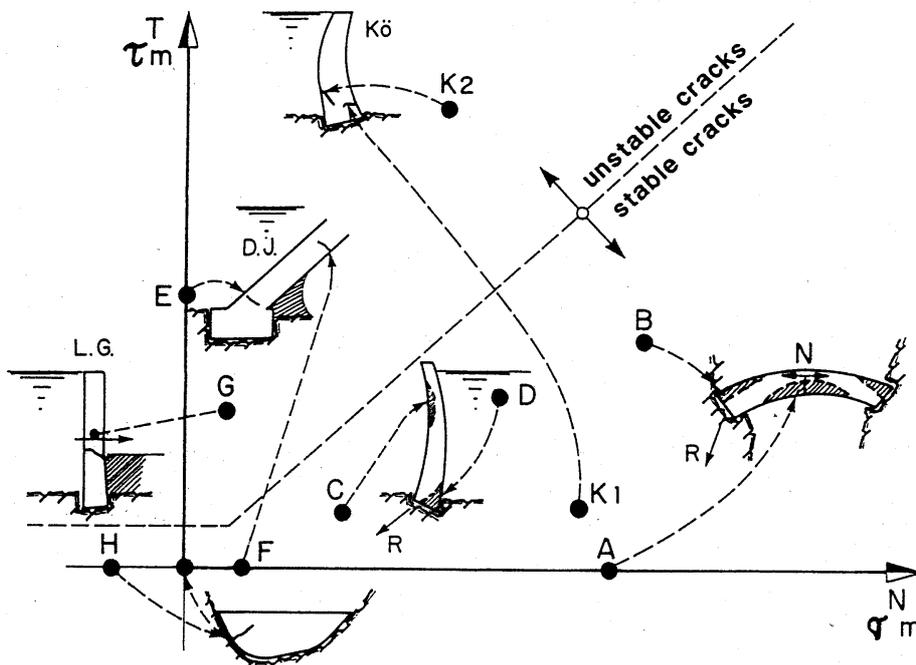
Figure 19 is an example of a trial in this direction.

Figure 19: Some typical cracks in arch dams.

N= normal force; T=transverse force; τ_m =respective stresses
