THE 2001 GOTTHARD ROAD TUNNEL FIRE

Tunnel Management International

Volume 7, Number 1, 2004 pp.33-39

A. Henke, Lombardi Engineering Ltd, Minusio, Switzerland

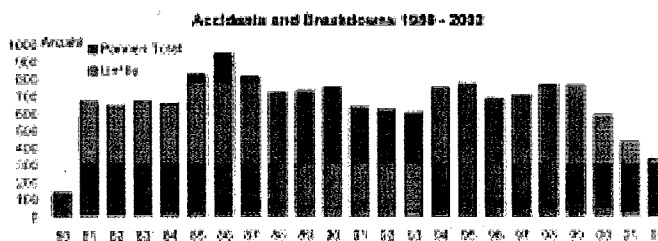
Figure 13: Accidents and breakdowns: 1980-2002.

The improved users' awareness has resulted in a considerable reduction in the number of accidents and breakdowns in the tunnel (see Figure 13).
