COMMISSION INTERNATIONALE  
DES GRANDS BARRAGES

VINGT-DEUXIÈME CONGRÈS  
DES GRANDS BARRAGES  
*Barcelone, juin 2006*

## **UPGRADING THE MAIGRAUGE DAM (\*)**

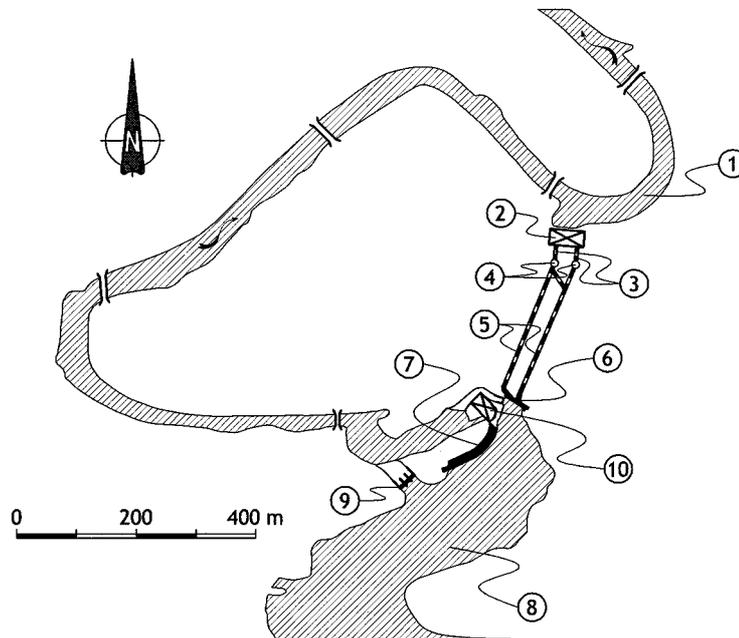
Fig. 1

General layout of the Oelberg-Maigrage scheme prior to rehabilitation works started in September 2000

552.70 m a.s.l. and el. 553.20 m a.s.l. The reservoir area is a protected natural zone, which means the reservoir can not be drawdown. The general layout of the dam and its appurtenant structures, as configured prior to the rehabilitation works, is schematically shown in "Fig. 1".

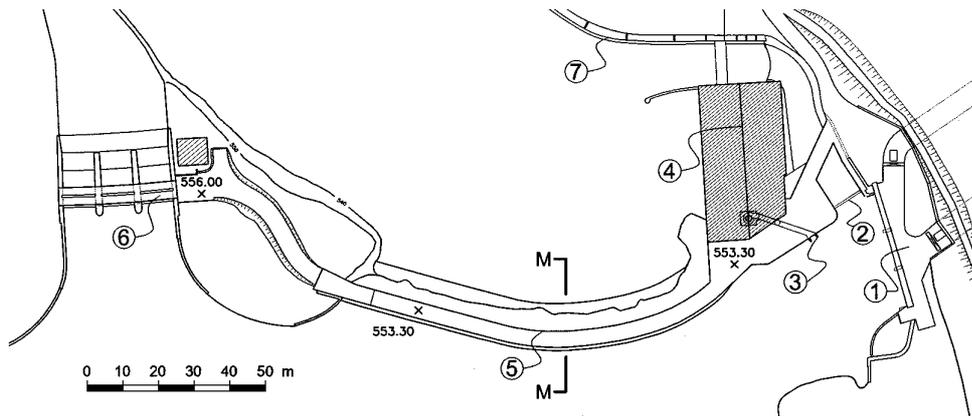
Fig. 2

General layout of the Maigrage dam and appurtenant structures after rehabilitation works completed at the beginning of 2004

The general layout of the dam and its appurtenant structures, as configured after the rehabilitation works completed at the beginning of 2004, is shown in "Fig. 2".

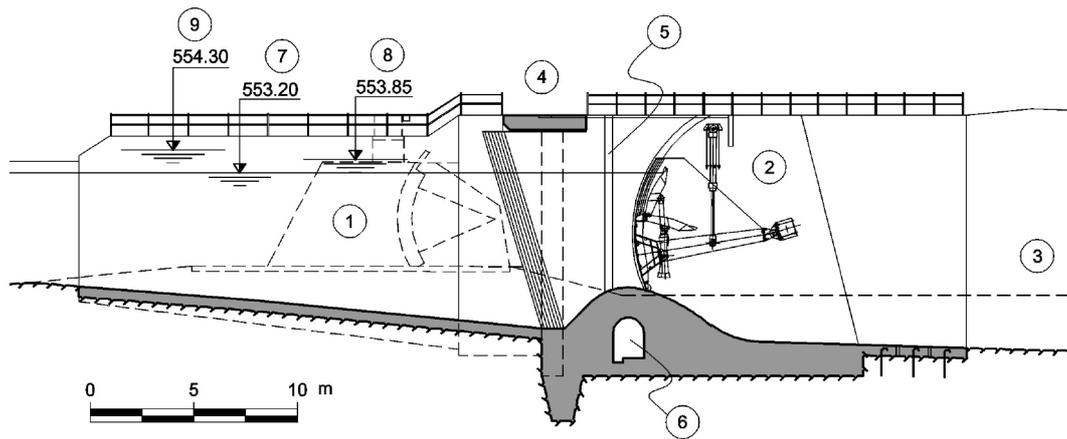
Fig. 3  
 Longitudinal section of the new spillway  
*Coupe longitudinale du nouvel évacuateur de crue*

The new spillway built on the left bank, instead of the existing weir, consists of three bays equipped with three 9.00 m wide, 5.91 m high radial gates. The latter are fitted with three 7.40 m wide and 2.20 m high flap gates, whose purpose is the regulation of water level and discharge of floating debris. The capacity of the spillway has been increased by lowering the sill crest by about 1.0 m and by improving hydraulic efficiency of the weir. The total spillway capacity is 915 m<sup>3</sup>/s at the maximum flood reservoir elevation (554.30 m a.s.l.), which is situated 1.10 above the normal water level. Construction of an upstream parapet on the dam crest avoids overtopping of the dam during extreme floods.

The new spillway has been built slightly downstream the existing one ("Fig.3"). In order to reduce the environmental impact, the alignment of the weir has been designed to minimise the effect on the actual structure and in particular on the chute walls. The 15.50 m long new overflow weir is slightly curved to reduce its width from 31.00 m upstream to 30.00 m downstream. The two intermediate piers are consequently varying in thickness from 2.00 m upstream to 1.65 m downstream. They are inclined upstream to facilitate the passage of floating debris. The 50 m long, 30 wide spillway chute has a 3% longitudinal slope. Excavated in sandstone, the chute is unlined with the exception of the first five meters from the downstream toe of the overflow weir.

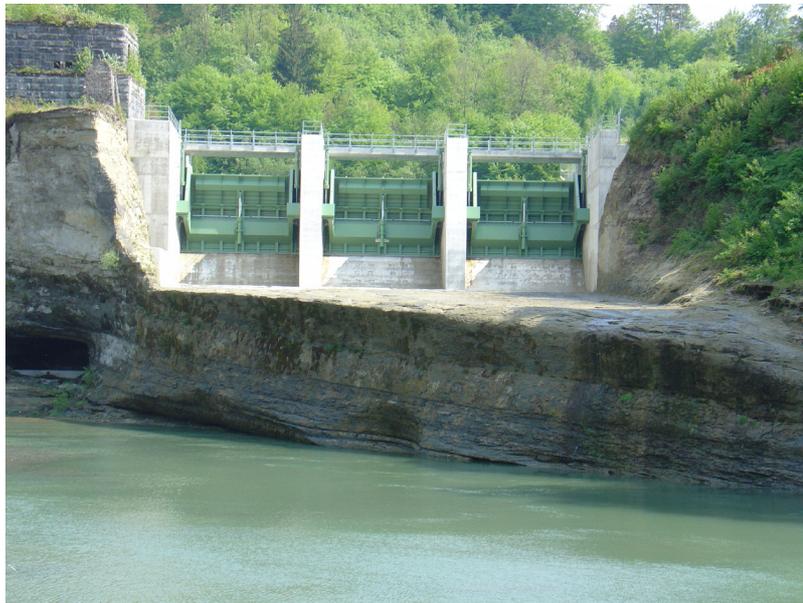
Fig. 4  
 Downstream view of the new spillway of the Maigrage dam  
*Vue aval du nouvel évacuateur de crue du barrage de la Maigrage*
