## INSTALLATION OF GATES ON THE SPILLWAY OF THE PUEBLO VIEJO DAM<sup>1</sup>

Roger BREMEN

*Lombardi Engineering Ltd., Minusio, Switzerland*

Q 79 : Gated spillways and others controlled release facilities

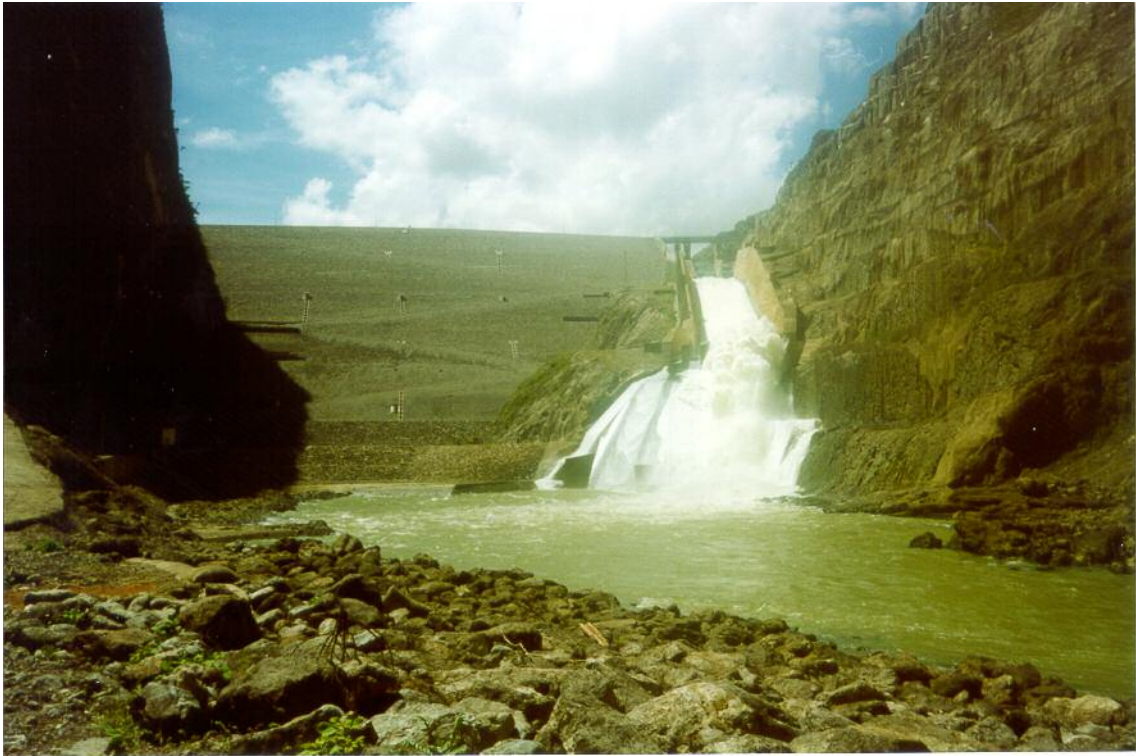
Fig. 2

Downstream view of the dam and the spillway chute.

The 26 km long headrace tunnel with a design capacity of 75 m<sup>3</sup>/s supplies the five Pelton units of the Quixal powerhouse. Figure 2 shows a general downstream view of the dam and of the spillway chute with the tailrace plunge pool in the foreground.

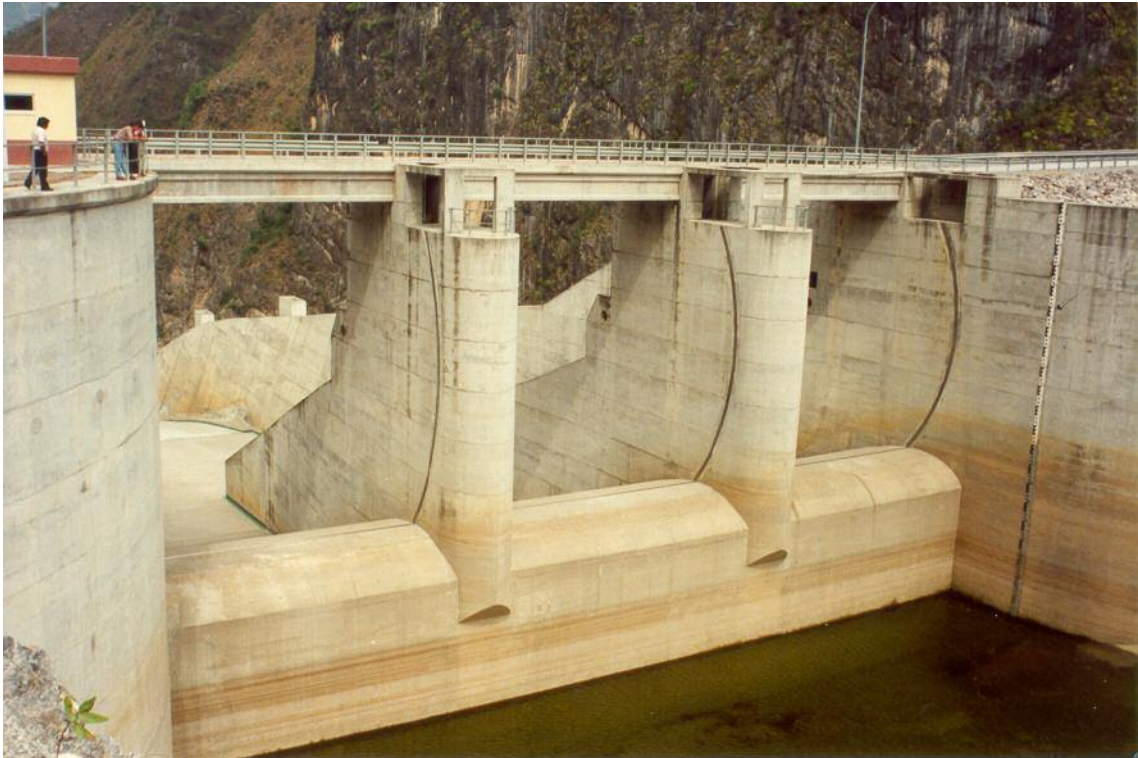
Fig. 3

Layout of the spillway bays prior to the modification works.

Figure 3 shows the general layout of the ungated spillway bays when put into operation in 1986.

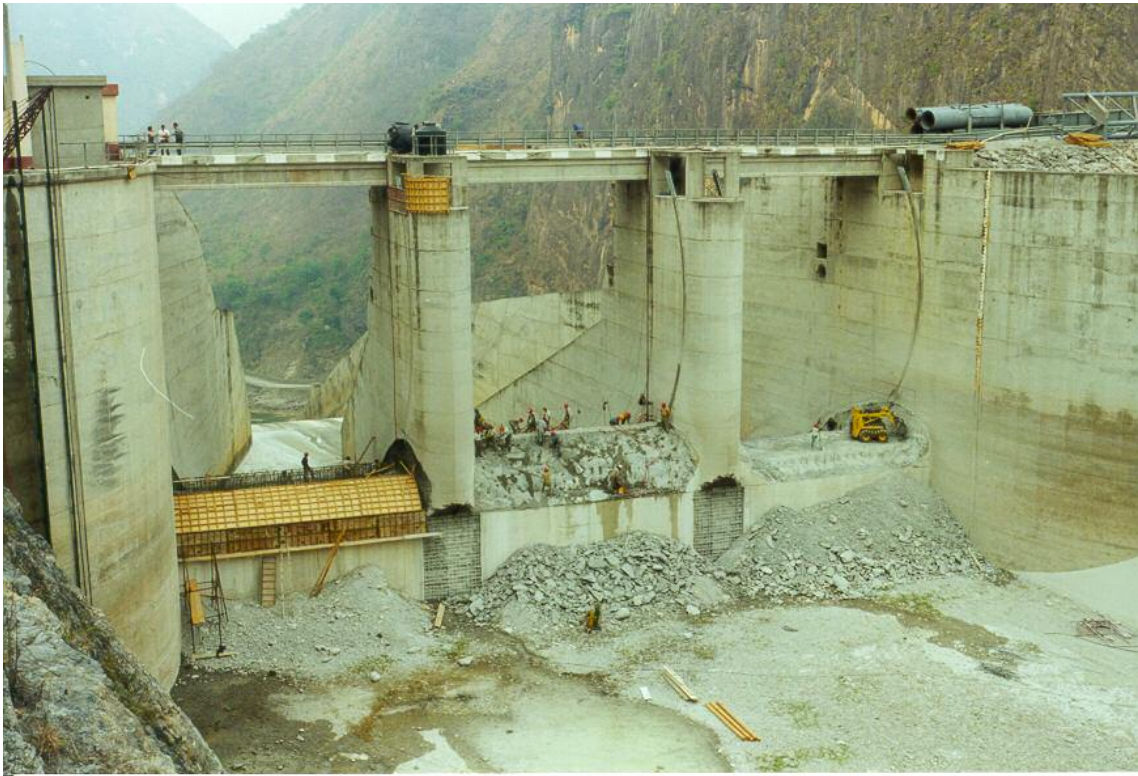
Fig. 5

General view of the demolition works on the spillway.

Only by mid-January 1998 the reservoir descended below el. 798.00 m a.s.l., allowing the beginning of the works on the spillway structure. For the removal of the 1200 m<sup>3</sup> concrete to be demolished, different methodologies were used depending on the concrete properties. The highly reinforced superficial concrete of the overflow weir was removed up to an average thickness of 20 cm using robotised hydro-demolition equipment with a pressure of 2000 bars. The same equipment was used for superficial concrete removal on the spillway piers as shown in Figure 5. Following the cutting of the superficial reinforcement bars, a 50 cm x 50 cm mesh of vertical drills down to the lower demolition limit (see Fig. 4) was executed on each spillway bay. The demolition and removal of the mass concrete was then carried out using various hydro-splitting jacks combined with pneumatic hammers. The demolition down to a maximum concrete thickness of 2.1 m was time consuming and somewhat difficult due to the locally dense reinforcement and the excellent mechanical properties of the concrete.

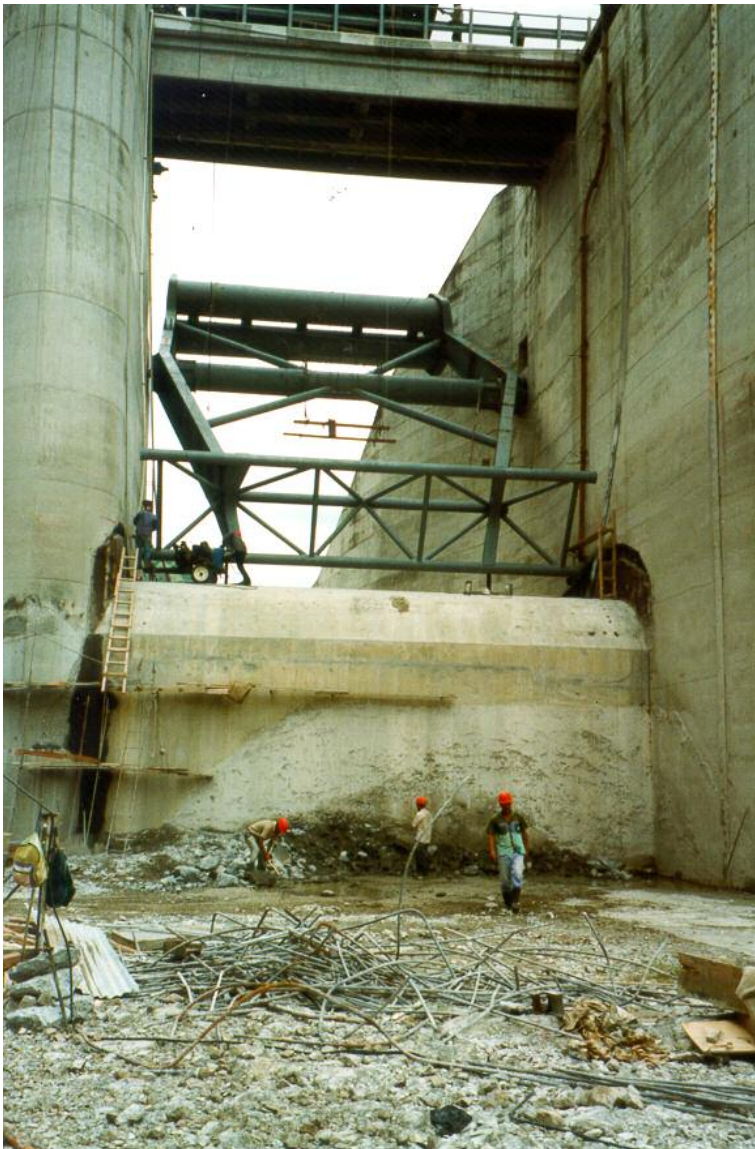
Fig. 6

Assembly of the skin plate with the main tubular beam on the modified overflow weir.

The gate sub-assemblies were lowered from the existing bridge by means of mobile cranes and the final assembly (welding and bolting) was performed directly on the spillway floor as shown in Figure 6. After the final assembly of the structural parts of the gates, the sand-blasting of site-welded joints and final coats of paint were carried out using the mobile cranes. Strong winds and heavy rainfall at the beginning of the winter season caused additional difficulties during painting and erection works.

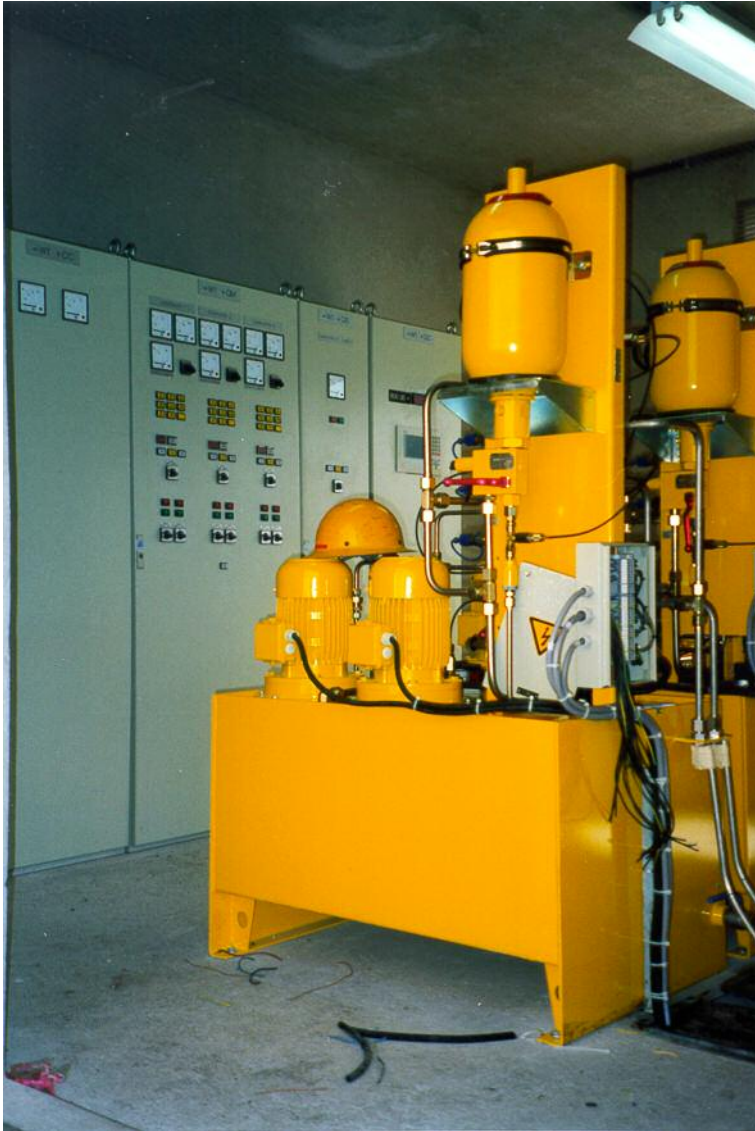
Fig. 7

Control room with oil pumping sets and electrical cubicles.

The electrical and hydraulic equipment was accommodated in a new two rooms control building located on the left dam abutment in front of the spillway. The oil pumping units with a service pressure of 250 bars and 250 litres capacity each, as well as the electrical cubicles, were installed in the first room as shown in Figure 7. The electrical equipment included, in particular, the following cubicles:

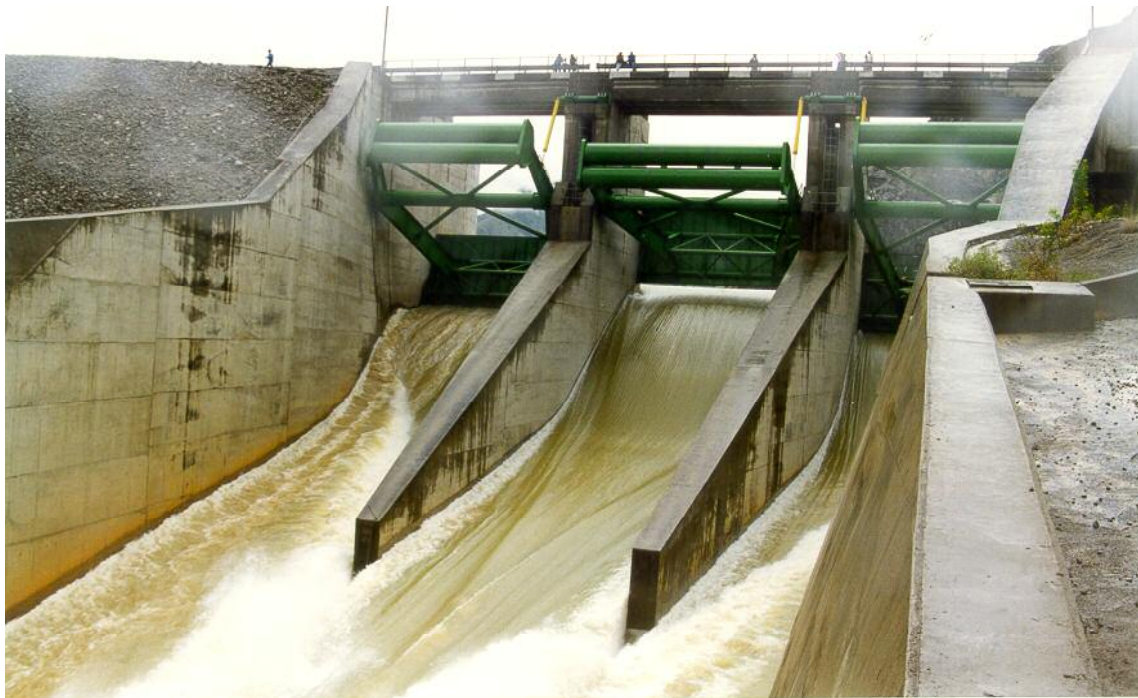
Fig. 8

General downstream view of the modified spillway with the installed radial gates.

For the provisional commissioning, only dry functional tests of the equipment were performed due to the low water level in the reservoir. A general view of the equipment at the provisional commissioning is shown in Figure 8.

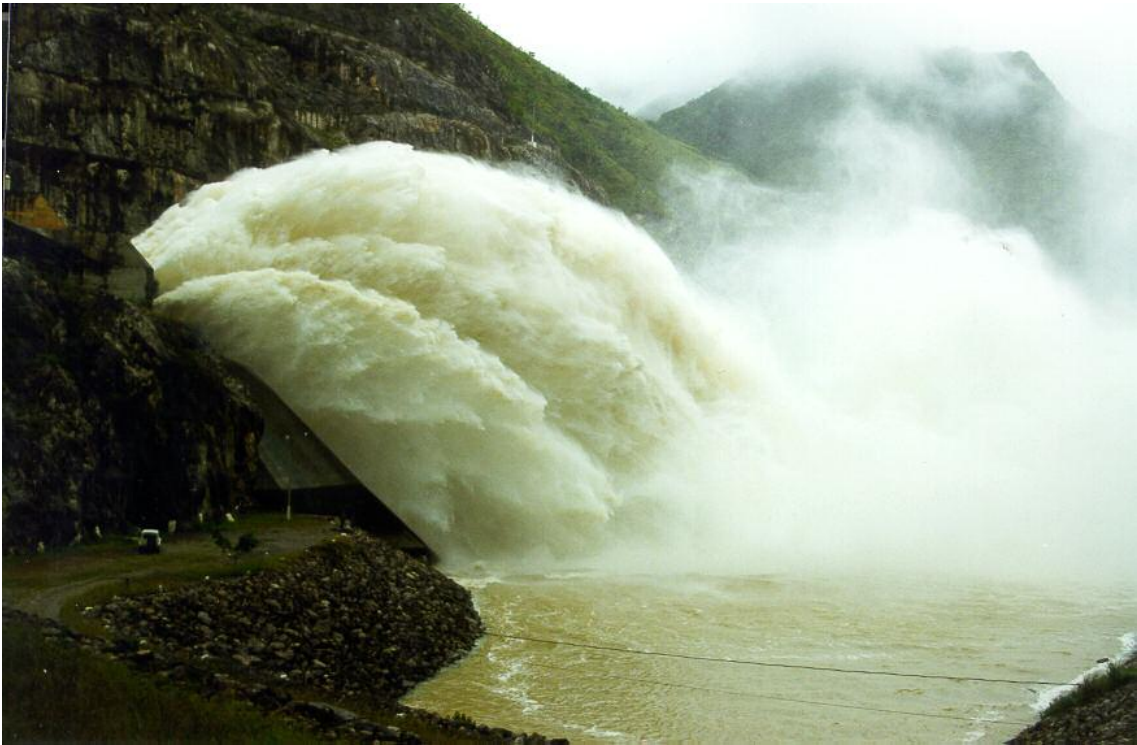
Fig. 9

Operation of the spillway's flip bucket during the Mitch hurricane,  
2 months after the gate installation.

Considering a reference cost for electric power of US\$ 0.05/kWh, results in a yearly benefit of approx. 2.0 mio US\$, which is of the order of magnitude as the costs of the spillway modification works. Figure 9 shows the operation of the flip bucket shortly after the completion of the gate installation.
